## Arboricultural Assessment and Report

Alexandra Parade Median  
Carpark,  
Fitzroy

22 December 2023 (revised)

Tree Logic Ref. 011874

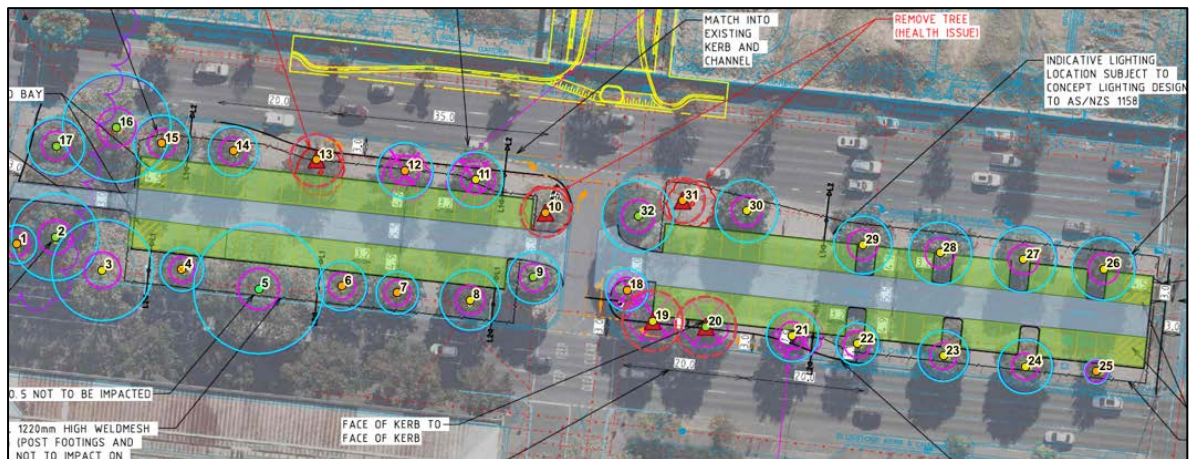
**Figure 4:** Showing proposed construction methods for different areas. Blue indicates a concrete surface, green indicates a grass grid system.

- The grass grid system has been proposed in response to the need to allow water and oxygen movement into the soil, especially in the TPZ. Levels of compaction are also critical in this zone, and after discussion with the engineer it was understood that the grid surface could be installed on a base layer compacted using a 2.6T flat drum roller with no vibration. Also, using a no fines aggregate, such as 20mm washed aggregate, would allow the retention of voids after compaction. Voids in growing media are critical for tree root growth as the voids allow root access, water movement and storage, and the diffusion of oxygen to the roots.

- The reduced weight of the roller and the lower levels of compaction have also been specified to reduce the likelihood of damage to roots in the Structural Root Zone. This zone is critical to the stability of the tree and while sympathetic construction methods can allow surface modification within the SRZ, it must be ensured that roots in this zone are not severed or crushed.

- No roots within the SRZ are to be damaged or cut. The carpark surface (grass grid section) must be installed at or above existing soil levels. Works within the SRZ of retained trees should be supervised by the project arborist.

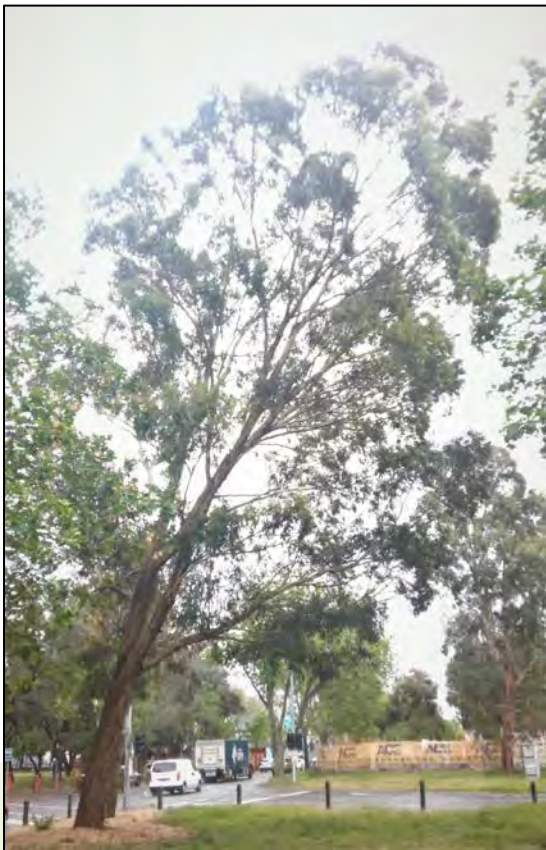
**Figure 4:** Tree 2, a Moderate A rated Yellow Box. Viewed from the east.

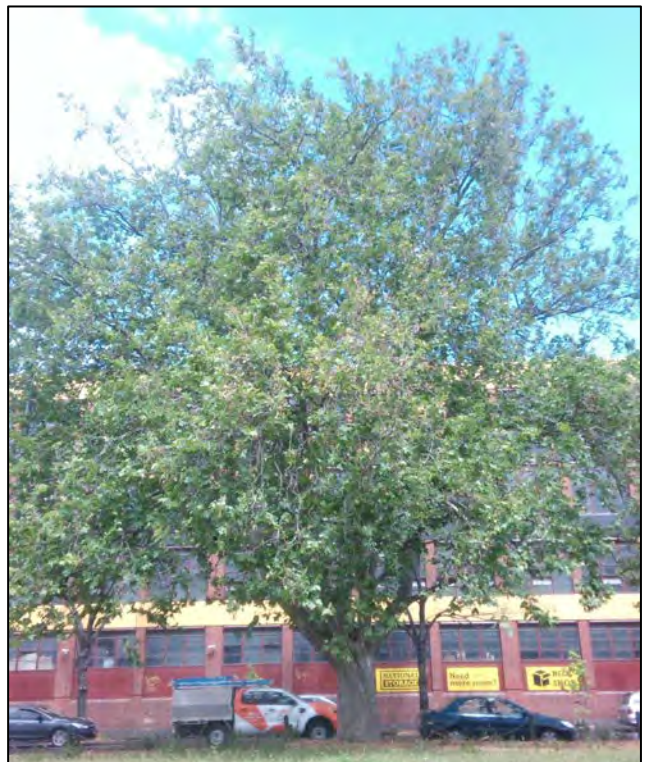
**Figure 5:** Tree 5, a High rated London Plane. Viewed from the north.

5	<i>Platanus Xacerifolia</i> (London Plane)	Maturing	90	104	21 x 20	Good	Fair	High	21-40 y	<i>Coprosma repens</i> seedling growing in primary union	Remove seedling growing in primary union	10.8	3.4	25	Major encroachment as per AS4970	City of Yarra Significant Tree (DBH)	Retain
6	<i>Ulmus Xhollandica</i> (Dutch Elm)	Semi-mature	34	37	10 x 8	Fair	Fair	Mod.C	21-40 y	foliage less developed than others on site		4.1	2.2	15	Major encroachment as per AS4970		Retain
7	<i>Ulmus Xhollandica</i> (Dutch Elm)	Semi-mature	29	35	10 x 9	Fair	Fair	Mod.C	21-40 y	decay in ascending limb to south (over west-bound lanes of Alexandra Parade)	Aerial inspection	3.5	2.1	8	Minor encroachment as per AS4978		Retain
8	<i>Ulmus Xhollandica</i> (Dutch Elm)	Semi-mature	35,22	45	10 x 10	Fair	Fair	Mod.B	21-40 y	over-extended limb to north with small dead wood	Deadwood; Reduce over-extended branch	5	2.4	20	Major encroachment as per AS4970	City of Yarra Significant Tree (DBH)	Retain

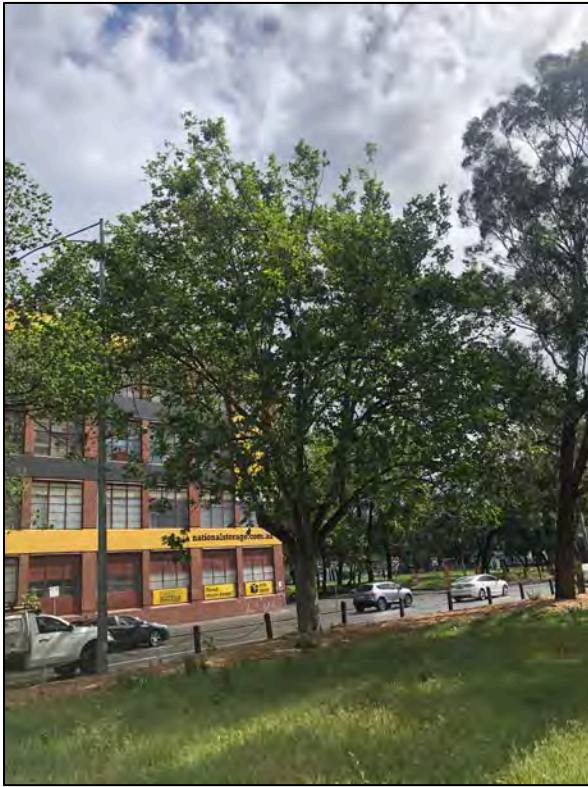
**Figure 6:** Tree 3, a Moderate B rated London Plane. Viewed from the north-east.

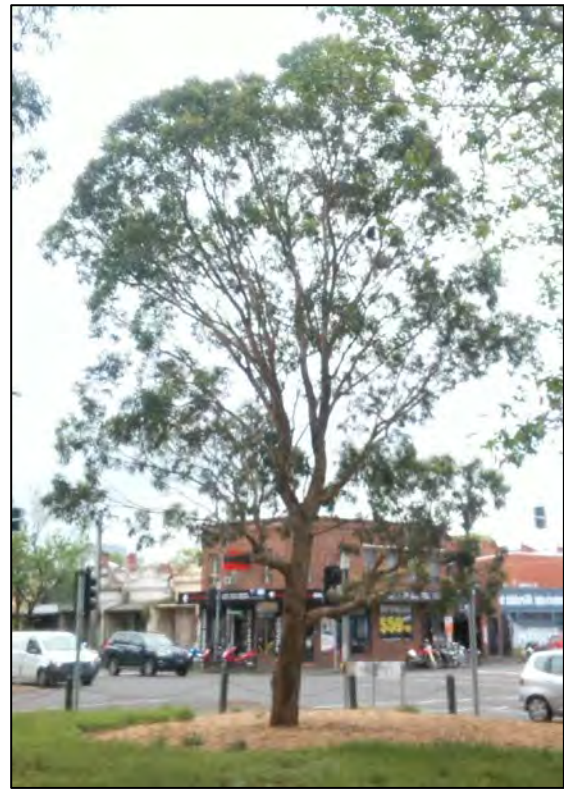
**Figure 7:** Tree 17, a Moderate A rated Yellow Box. Viewed from the south-east.

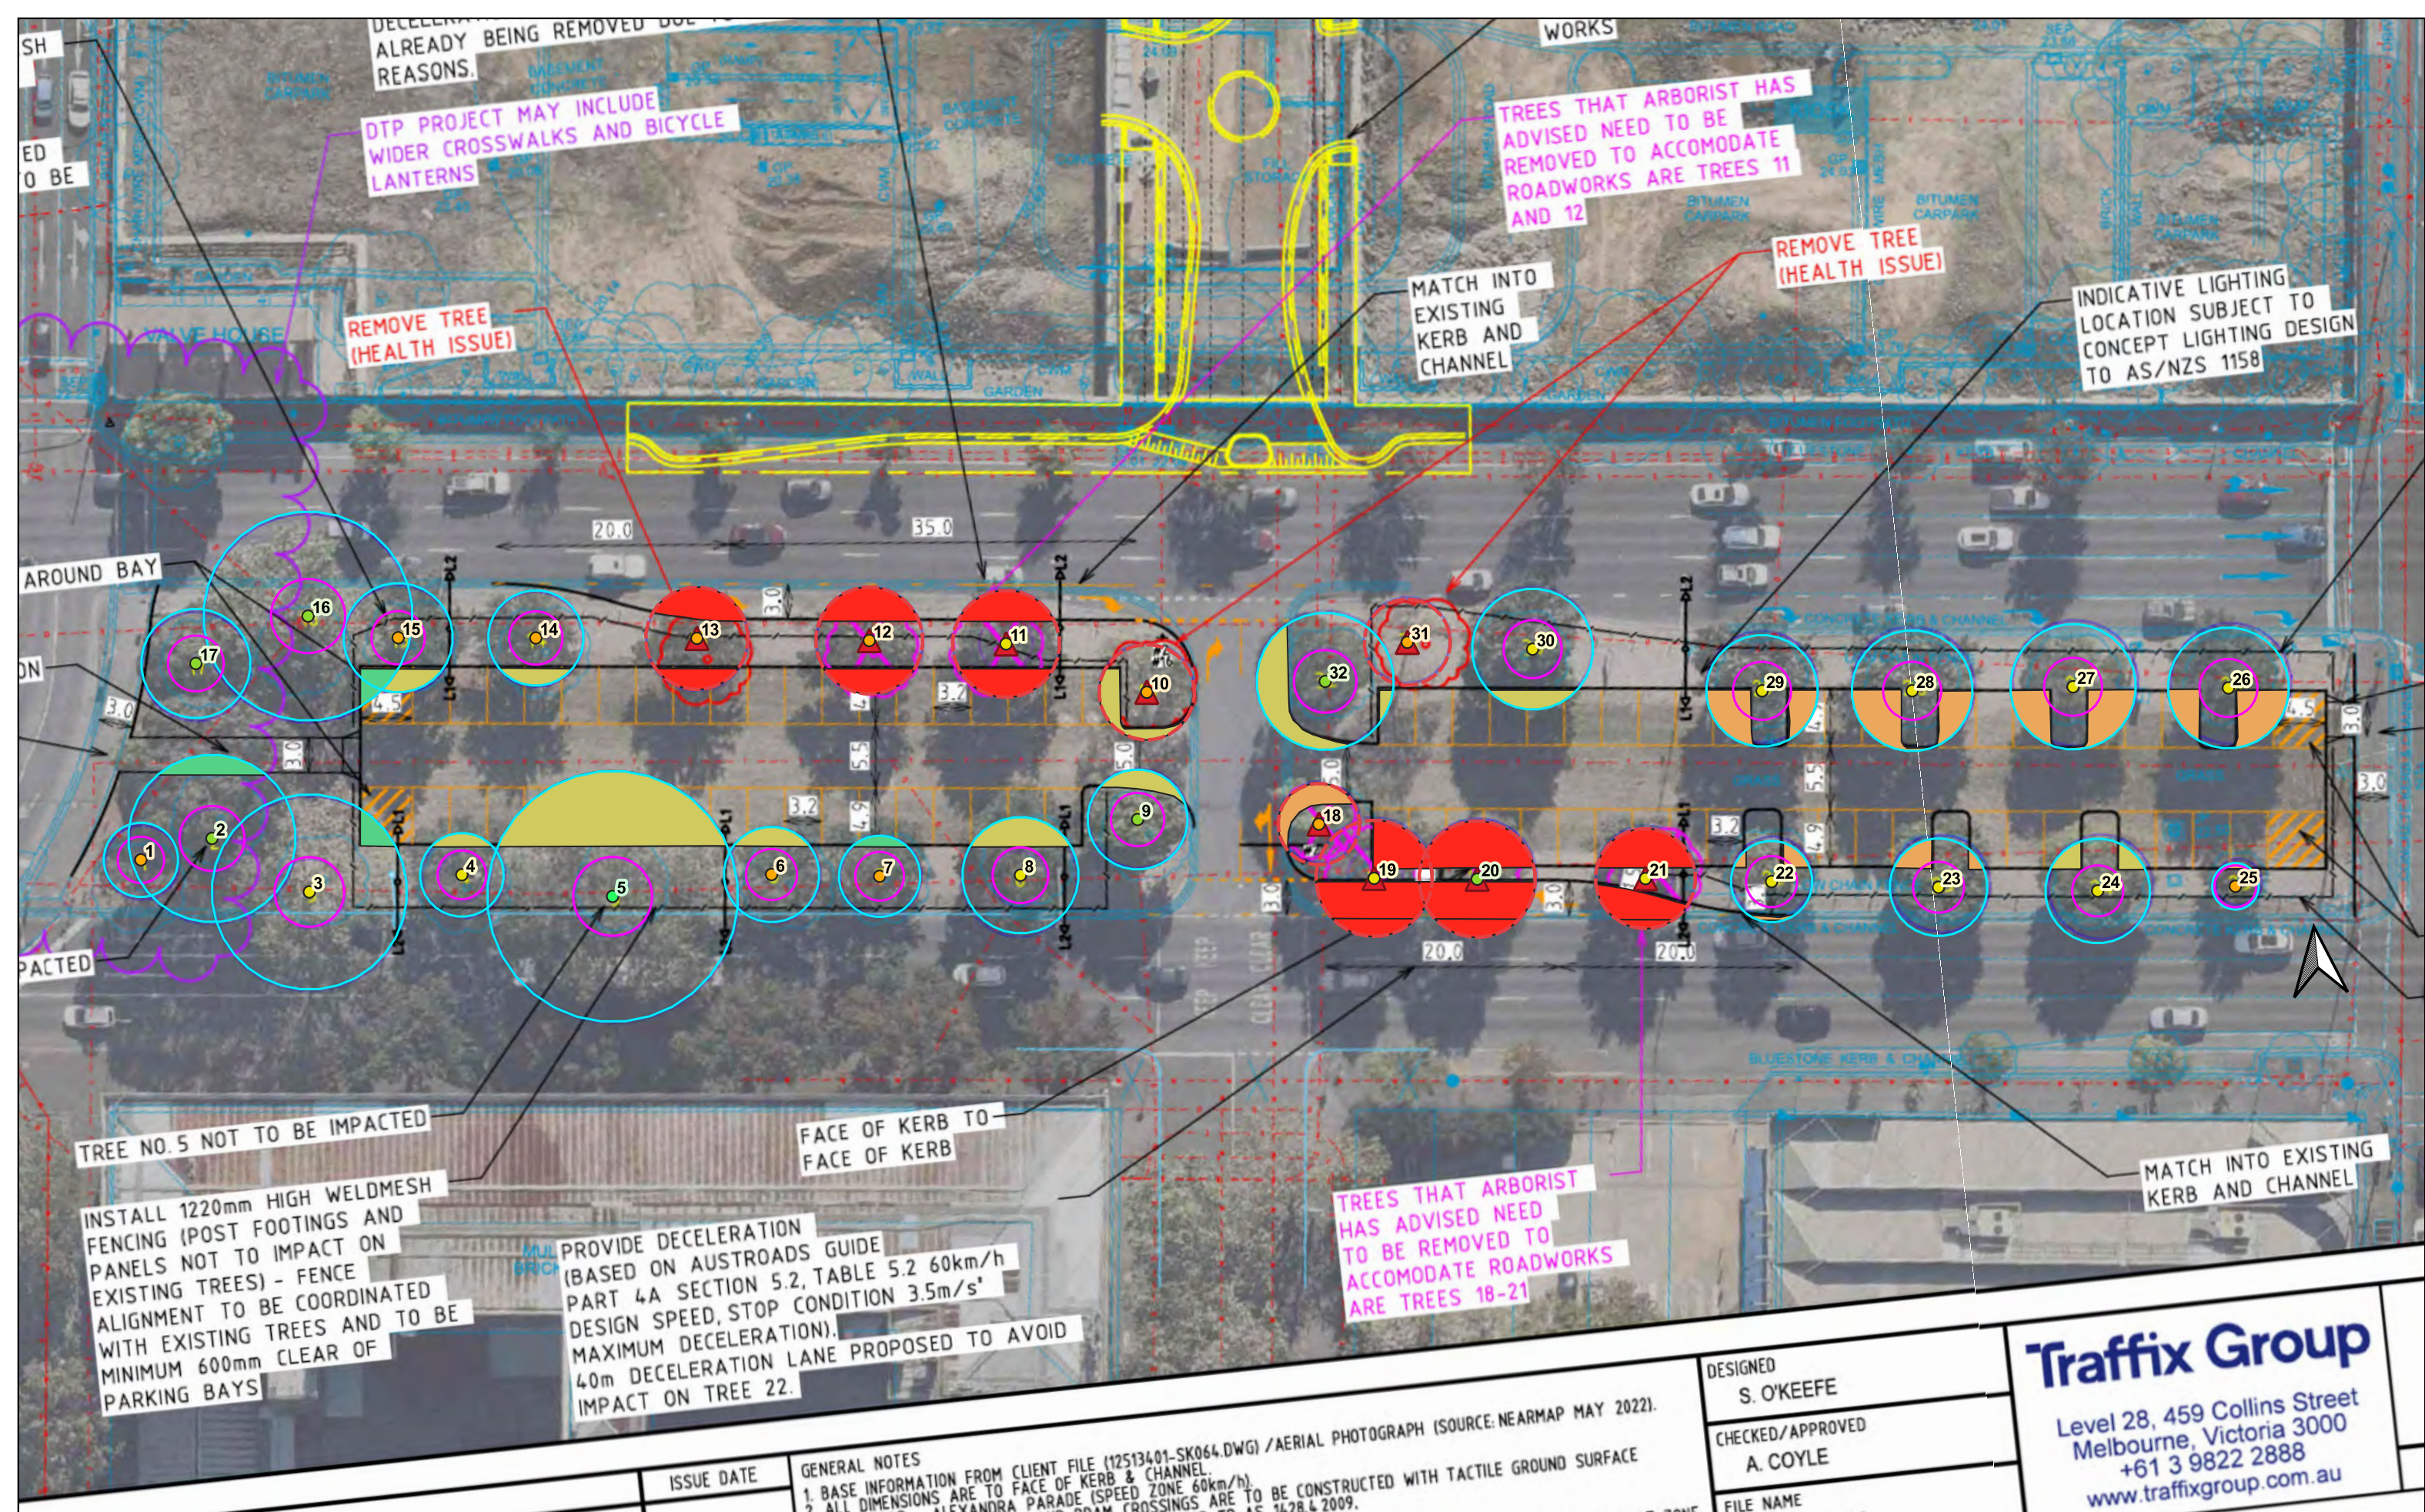
**ENCROACHMENTS — TREE LOCATIONS AND PROTECTION ZONES**

- Open space allocations into the carparking spaces have been given to trees 22, 23, 24, 26, 27, 28, and 29. While these trees will experience encroachment of their SRZs, if the works are conducted according to the recommendations above, in our opinion they are likely to tolerate the proposed design.

- Trees 10, 13 and 31 are recommended for removal due to wounds, the presence of borers and generally poor structure.
- Trees 11 and 12 are impacted from two sides of their TPZ, to the north from the new sliplane and from the south from the carpark surface. These trees are unable to be retained under the proposed design.
- Trees 19, 20, and 21 are lost to the construction of a new sliplane allowing cars to enter the central access road between the two carparks. These trees are unable to be retained under the proposed design.

- Maintenance of an exclusion zone over the open ground around the perimeter of the carpark will be critical to realizing the retention of the trees in question. This open ground represents the new ground space where trees will be able to regrow roots that may be lost to changes in conditions. Strict tree protection exclusion fencing should be installed before works commence and maintained for the duration of the works.
- No storage of machinery or materials should be allowed in this protected space.
