**INTERIM REPORT:**

Tree collapse and bank slump investigation on Yarra River adjacent to former Amcor site at Alphington

August 2019

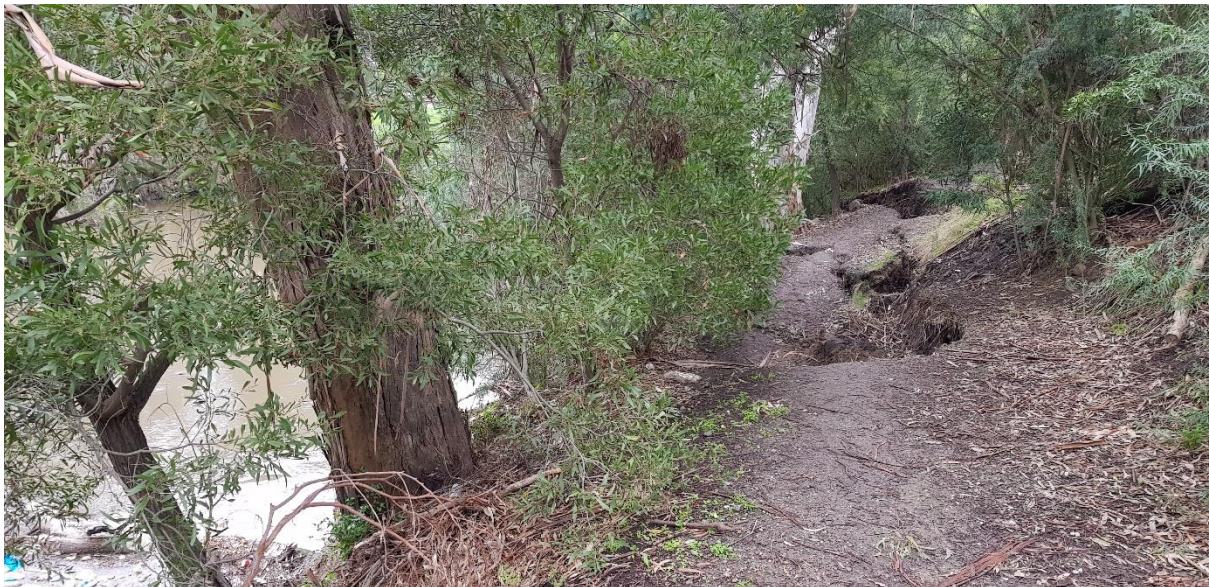
**Figure 3.** *Tree collapse (T2) at the edge of bank slump*

- removal of trees at risk. Tree T1 has now been felled. We propose that Tree T2 be the subject of a regular (weekly minimum) monitoring program.
- Reducing access of air to the root zone of remaining trees. This can be achieved by infilling tension cracks.

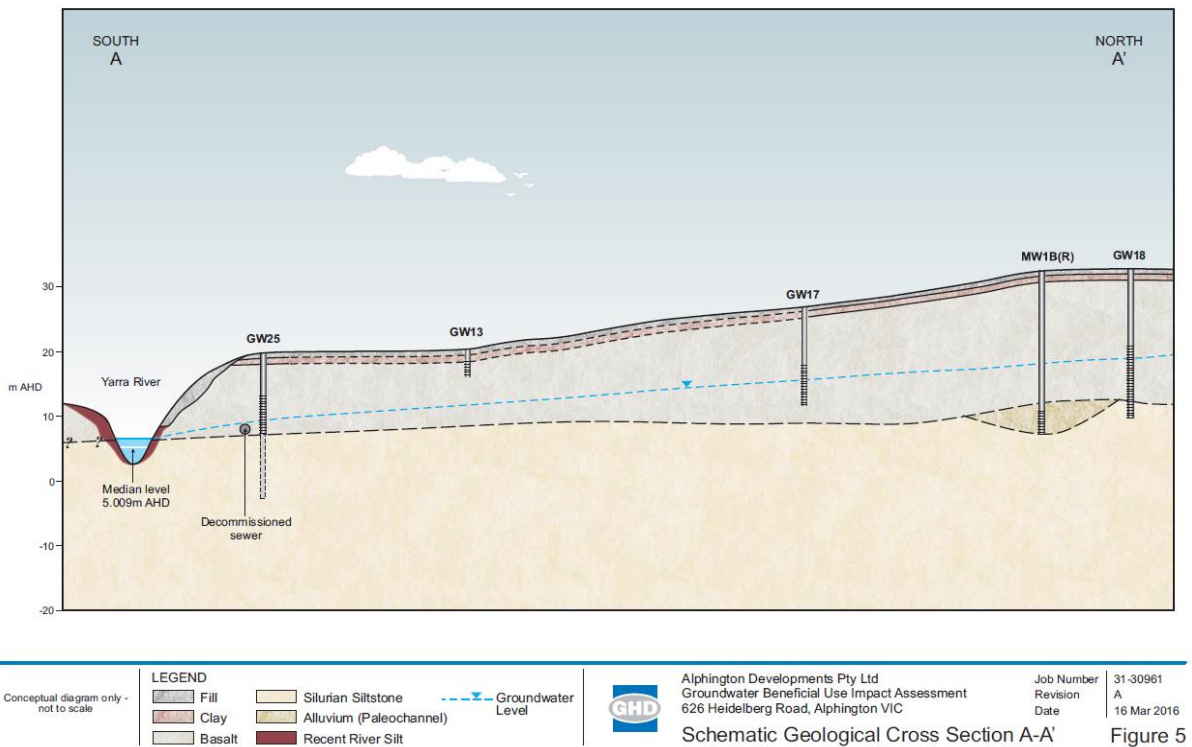
- **Sewer main decommissioning:** We understand that a sewer main, close to the subject bank, has been recently decommissioned and infilled with grout. The location of the sewer main is shown in Figure 5.

Figure 5 Cross section of the subject site including location of decommissioned sewer main (source GHD 2016)

We understand that the grouting of the sewer main occurred over a wider extent than the subject site. While we cannot completely discount this pathway, the mechanism does not accord with the observed groundwater impacts being limited to the subject site. This potential mechanism should be investigated in the more detailed stage 2 investigations.

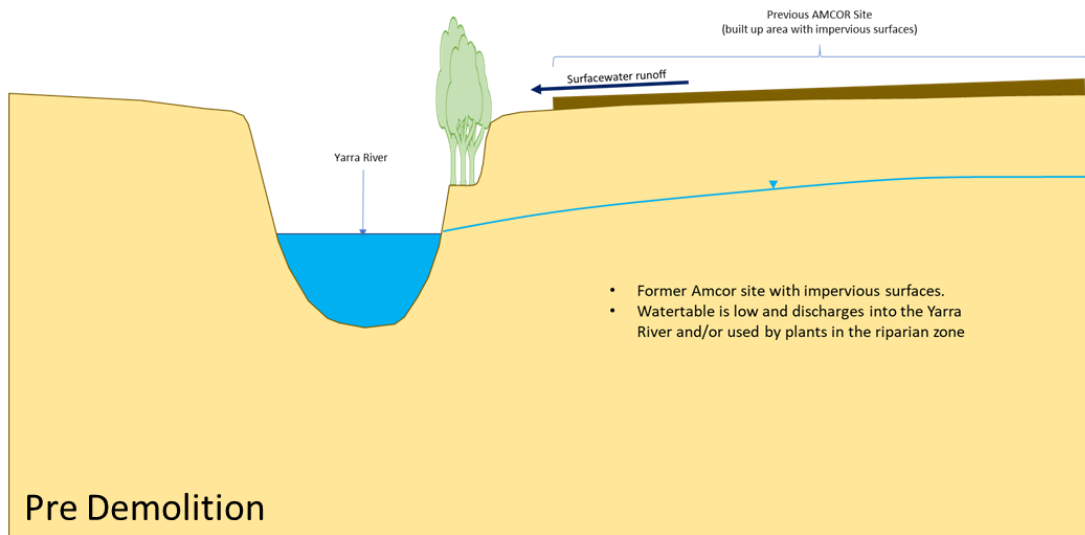
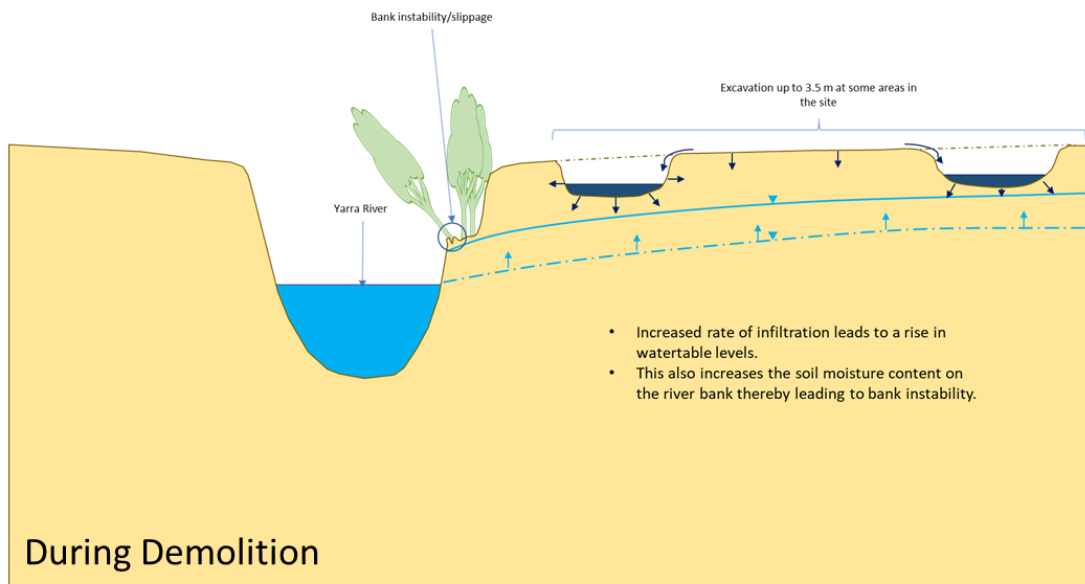
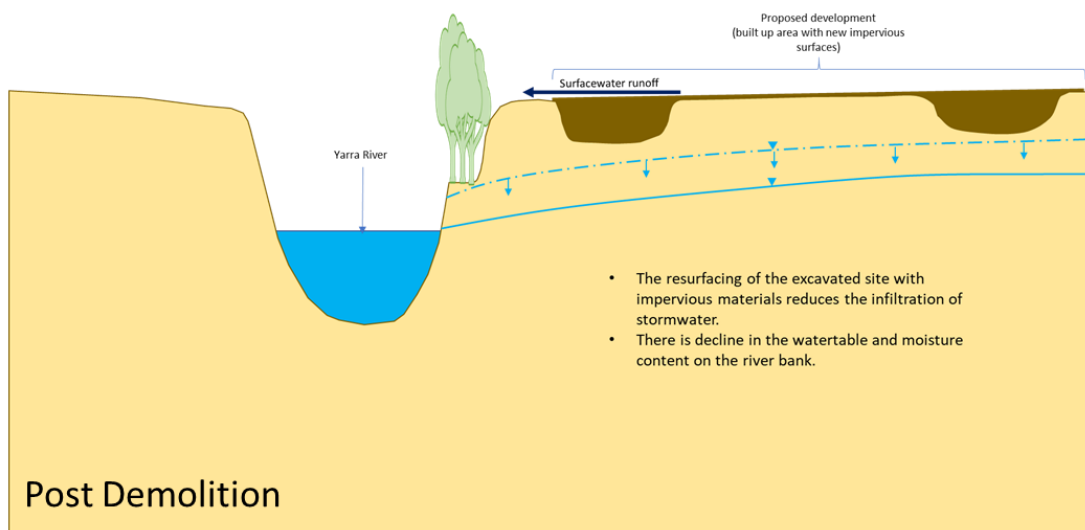
However, based on the information available, the expert panel is of the opinion, that the most likely source of the elevated groundwater is a change to the rate of surface water infiltration at the subject site. This process is illustrated in Figure 6.

Figure 6 Conceptual model of possible changes to groundwater levels at the subject site (source CDM Smith refer appendix B)

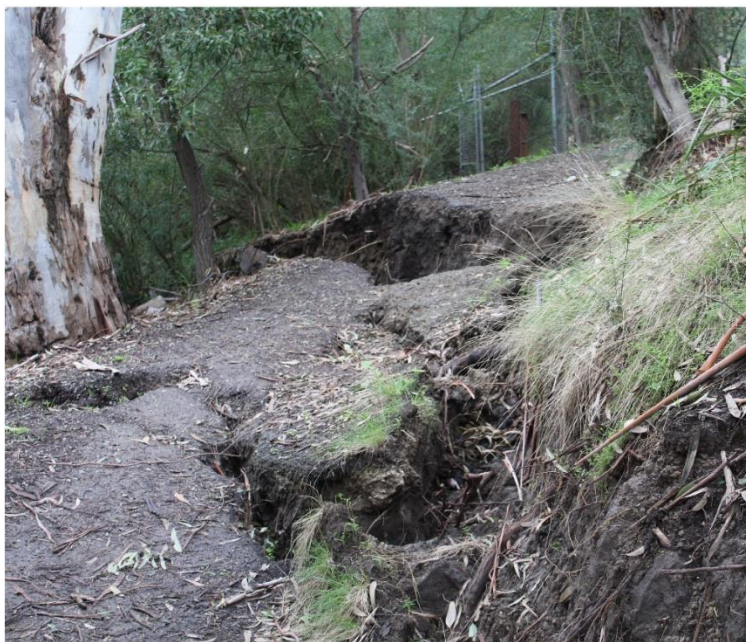
Figure 1 – Bank collapse

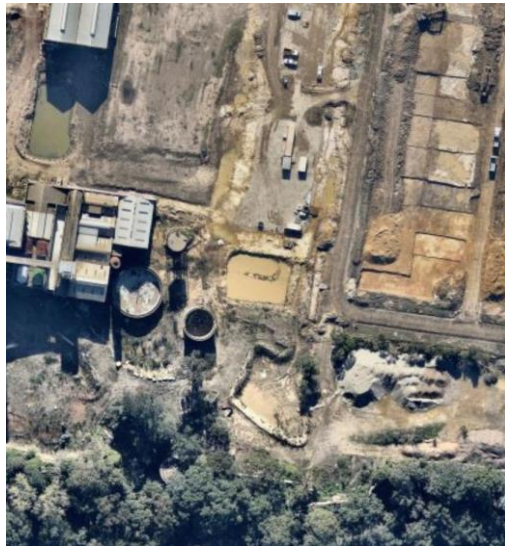
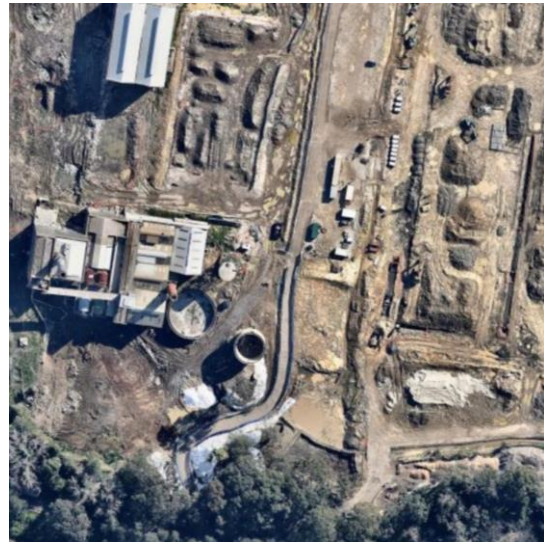
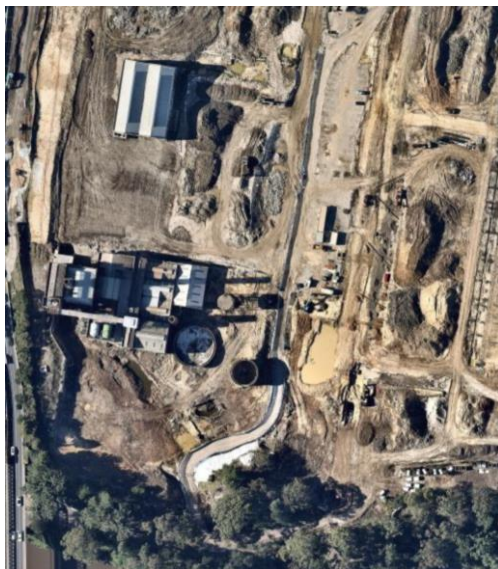
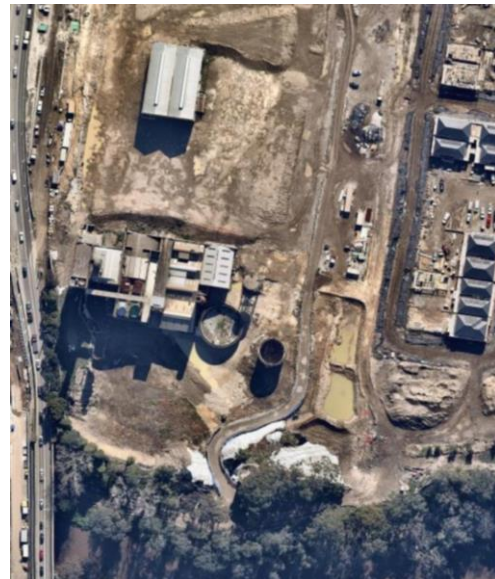
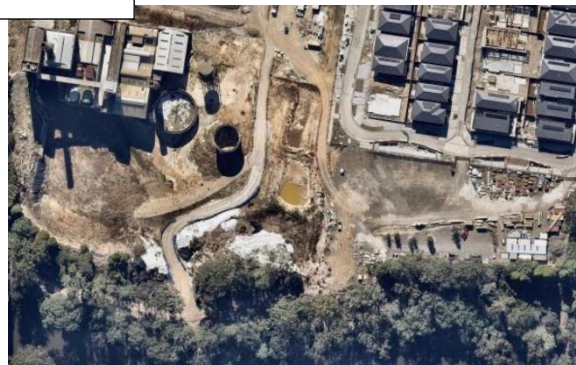
From an examination of aerial images, it is clear that the location of the surface water management sedimentation ponds has moved over time (see Figure 3).

**Figure 3** – Images showing the change in sediment pond location over time

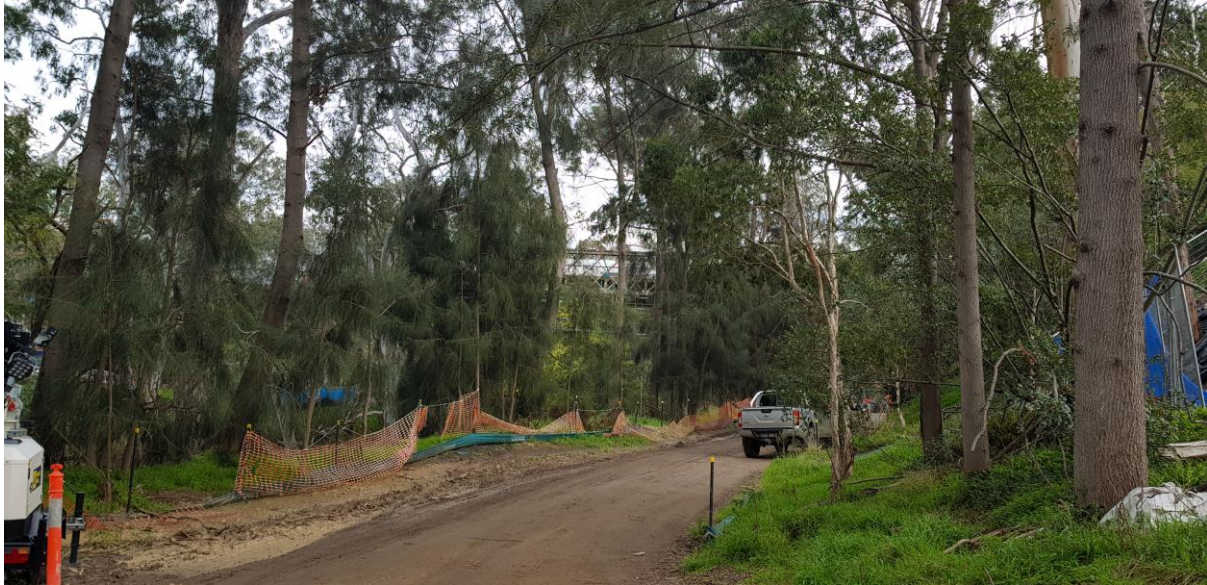
**Figure 8:** Riparian planting west of slump area -River Red Gums occur along the riverbank. The waterway corridor is predominately planted with non-indigenous natives. Newer plantings are local indigenous plants.

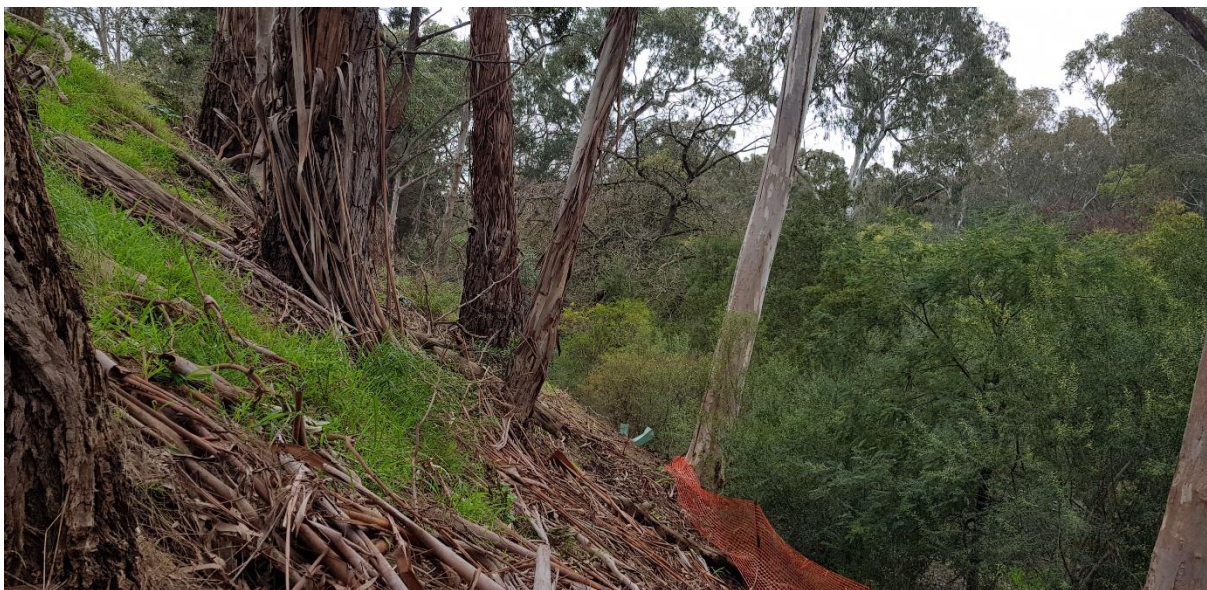
**Figure 9:** Planted trees on embankment - Trees on the embankment are 20+ year old non-indigenous natives. The trees on the embankment are growing at different angles to each other. Investigate for slumping or ground heaving to determine stability of the trees.

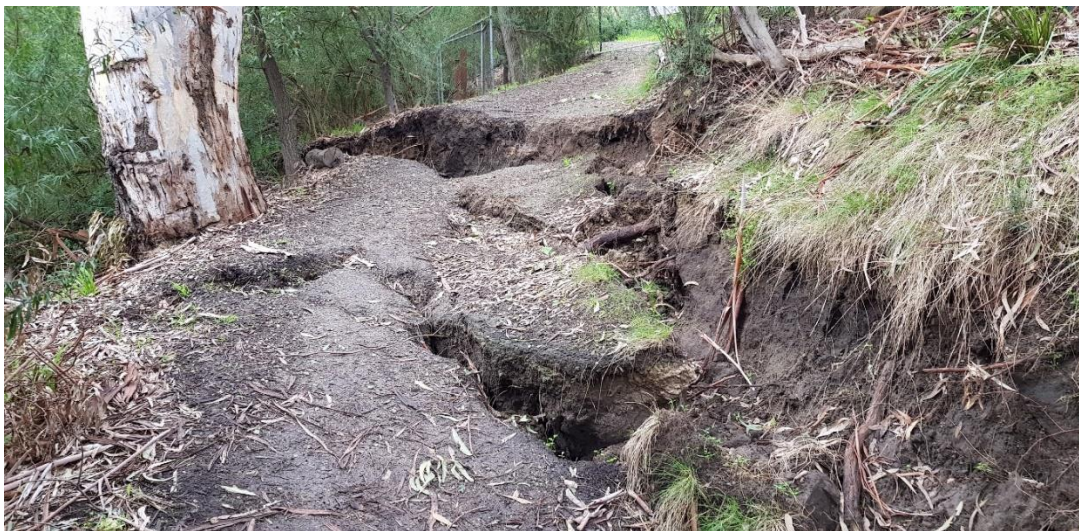
**Figure 11:** Tree (T1) and bank slump site visit by Alluvium

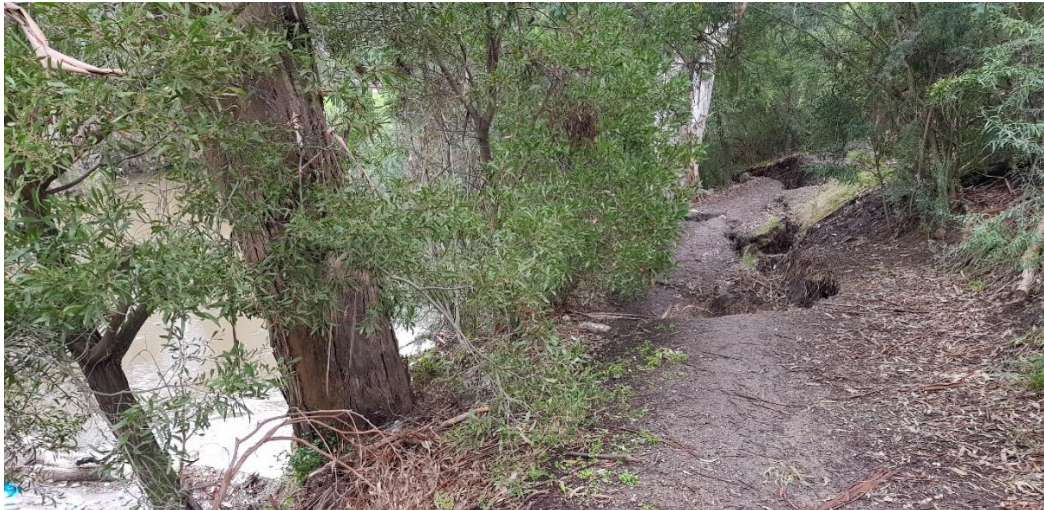
**Figure 12.** *Tree collapse (T2) at the edge of bank slump*

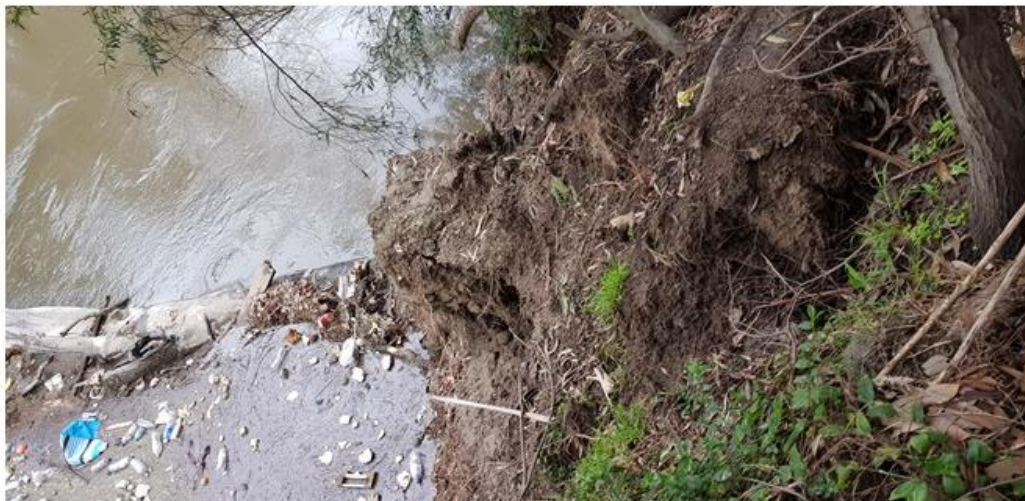
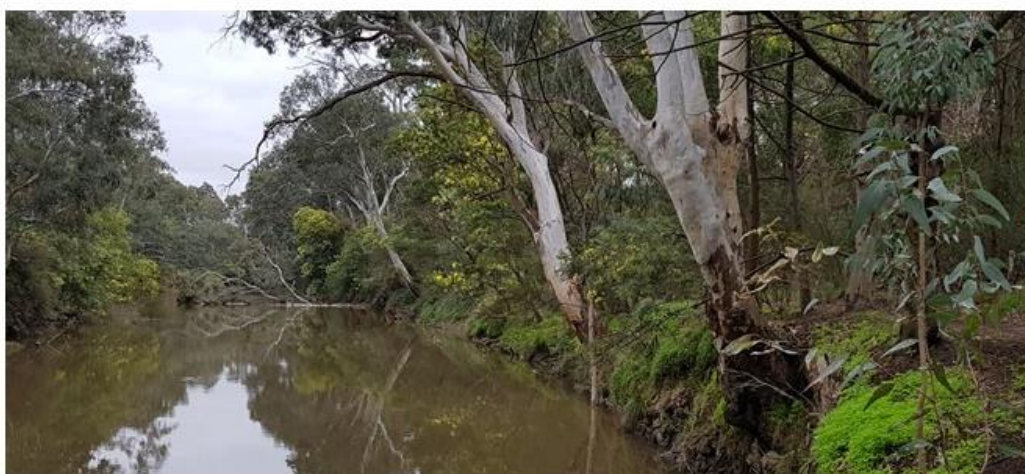
The tree which has fallen into the river (see Figure 13) is firmly held into the riverbank and has not swung around with the river current. This suggests that the tree had a healthy root system prior to falling.

**Figure 13:** *Tree in slump which has fallen into river*

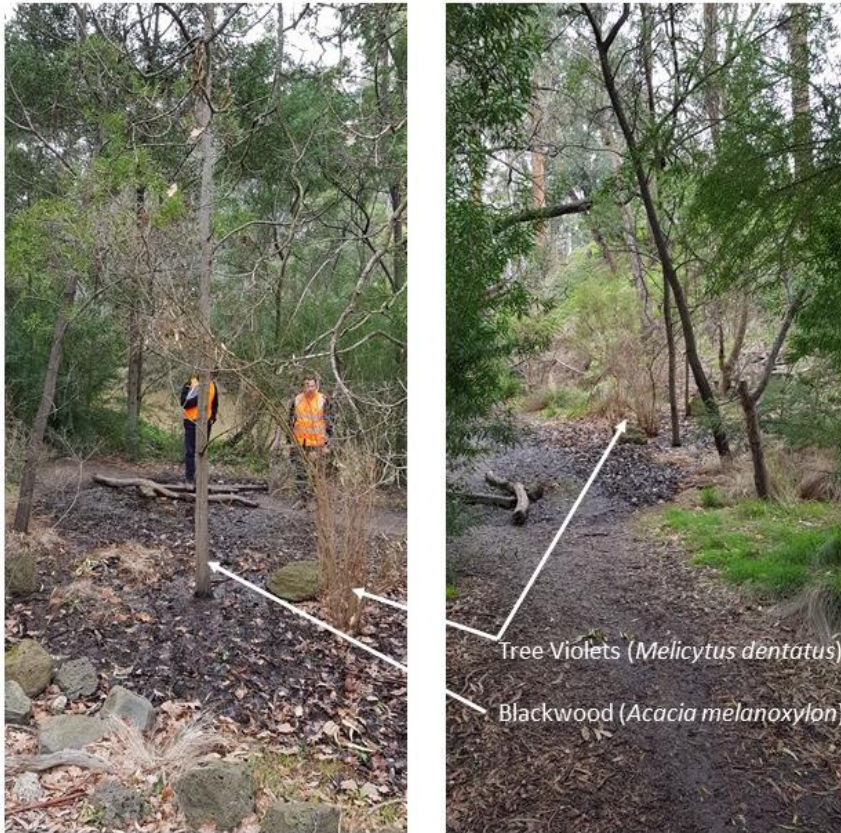
**Figure 14:** *Dead native plants in waterlogged area*

Figure 14 shows an area where some planted native plants (<5 years old revegetation) which were growing well but are now dead. They are in a waterlogged area. The same species growing nearby in non-waterlogged soils are growing healthily. This indicates that the ground conditions have changed affecting the plants – estimated to be within 5 years.

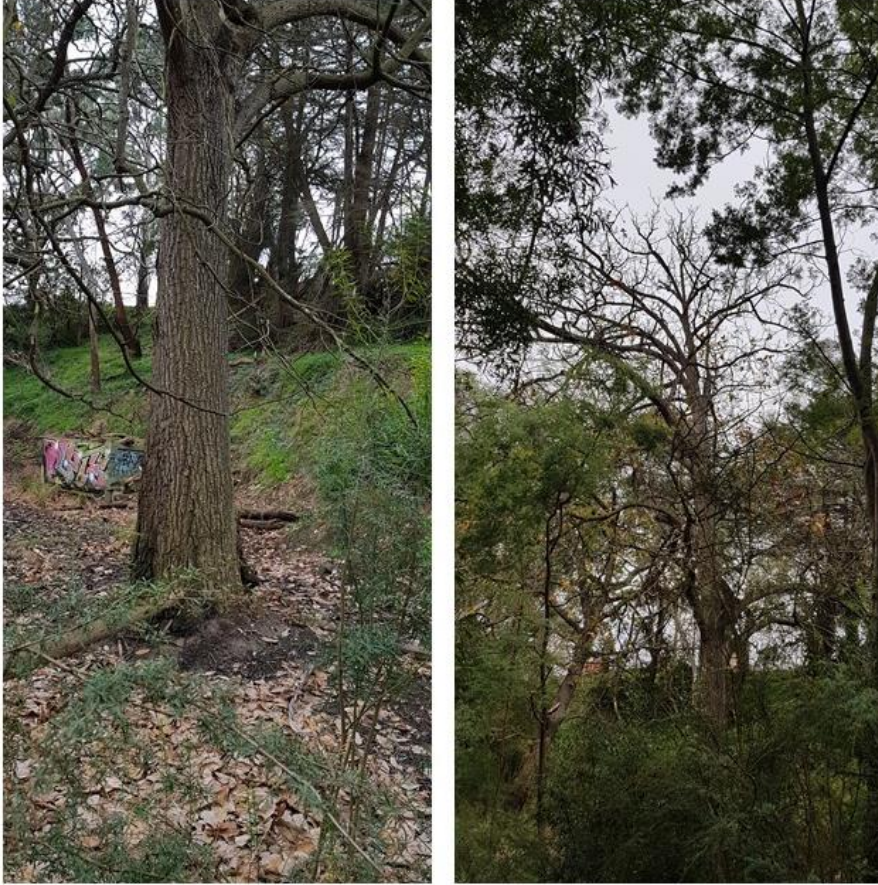
Some mature Oak trees are growing within and adjacent to a waterlogged area. These are significant local trees and would be a priority to be retained in a future landscape. One of these (see Figure 15) appears to also be suffering from the waterlogged ground. These trees need to be assessed in spring to check the seasonal regrowth and their health.

**Figure 15:** *Oak in waterlogged area*

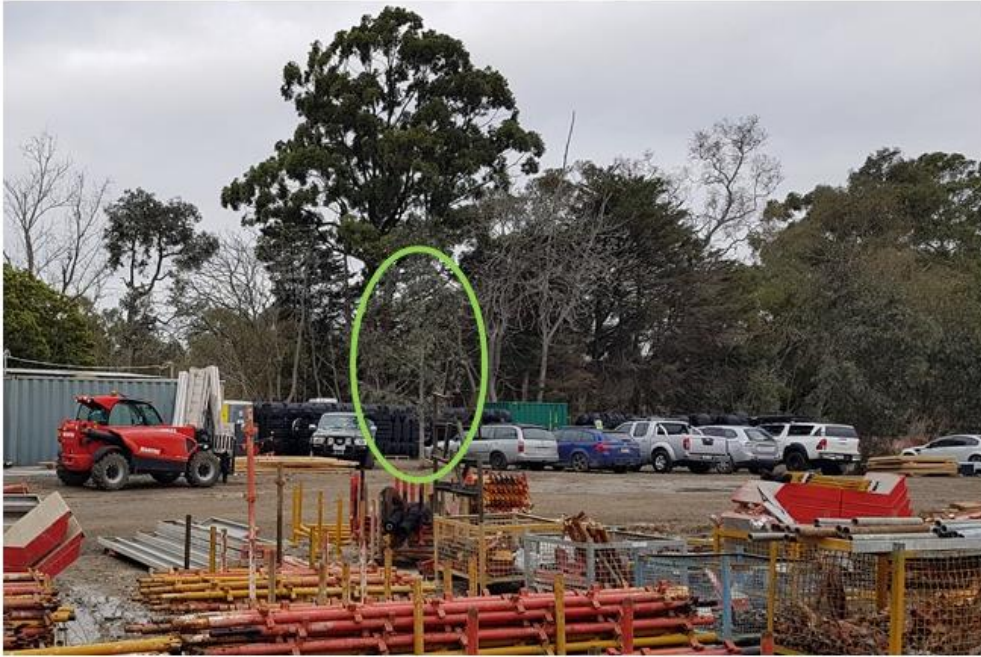
A Eucalyptus species (see Figure 16) has grown in the construction carpark with was a concrete covered hardstand (see Figure 23). This tree has grown >4.5m since 2016. This indicates that the ground in this area is not highly compacted and has moisture to enable rapid growth. This rapid tree growth suggests that the carpark area has well-watered but free draining soils, consistent with a site that has high levels of surface water infiltration.

Figure 16: Juvenile tree in carpark - old logistics hardstand

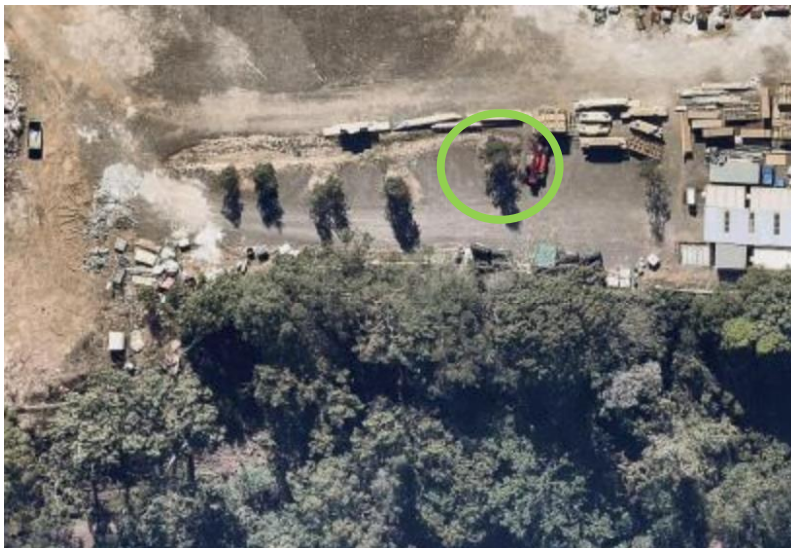
Figure 23: Juvenile Eucalyptus growing in carpark

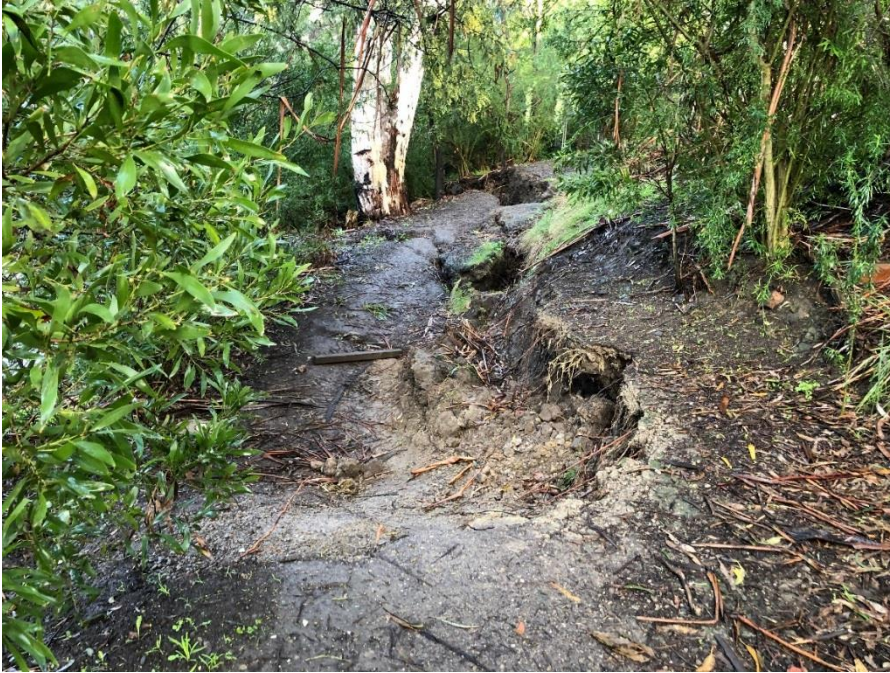
**Tree T1 on and related bank slump 12 August 2019**

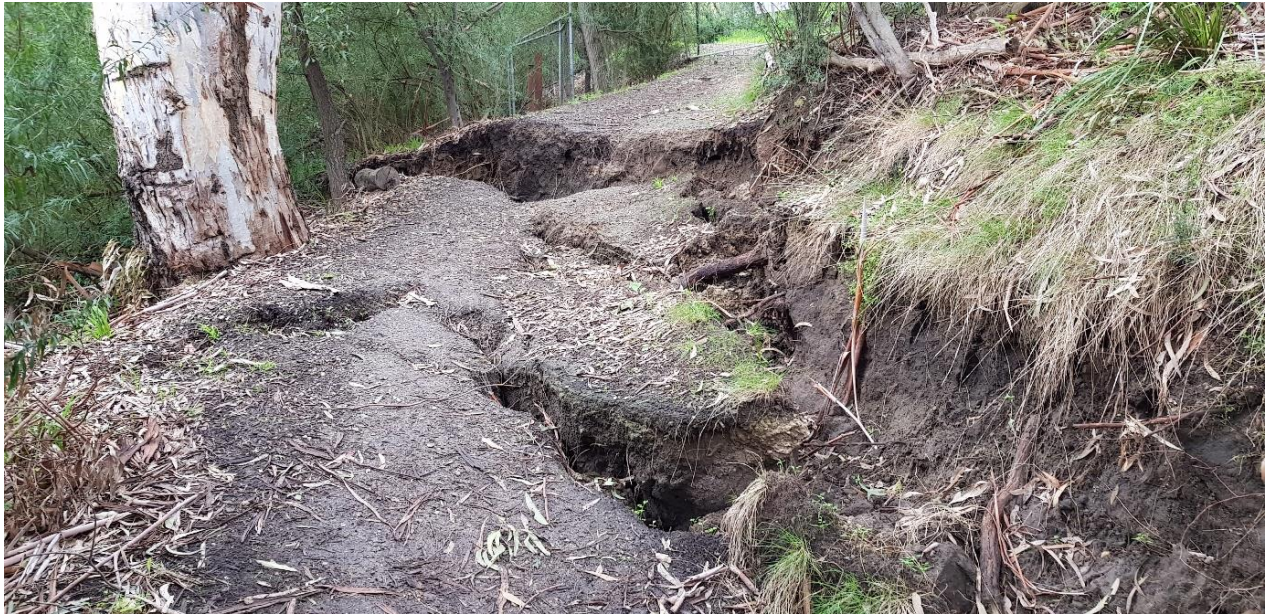
**Figure 18.** *Tree collapse site*

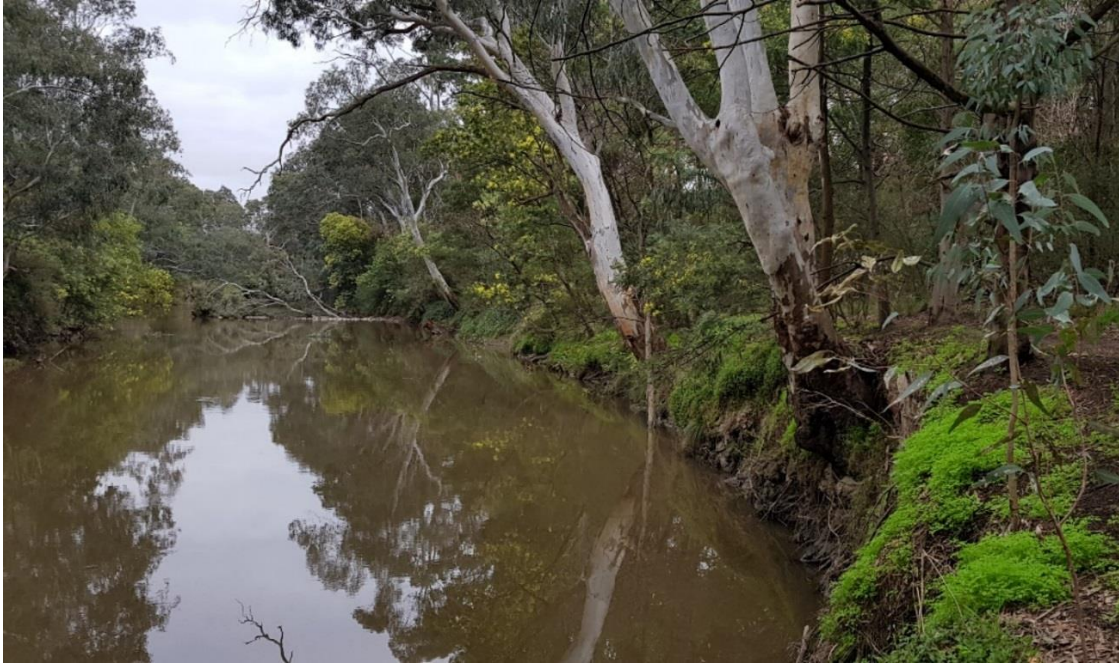
The lower terrace and steep embankment have been revegetated with non-indigenous native trees. However, the edge of the riverbank comprises indigenous river red gums, likely to be from natural regeneration. The root material from the river red gums provide a matting within the clays and fine silts making up the riverbank material.

Figure 19. Root material along bank of Yarra River at subject site
