## Arboricultural Assessment and Report

Alexandra Parade Median  
Carpark,  
Fitzroy

22 December 2023 (revised)

Tree Logic Ref. 011874

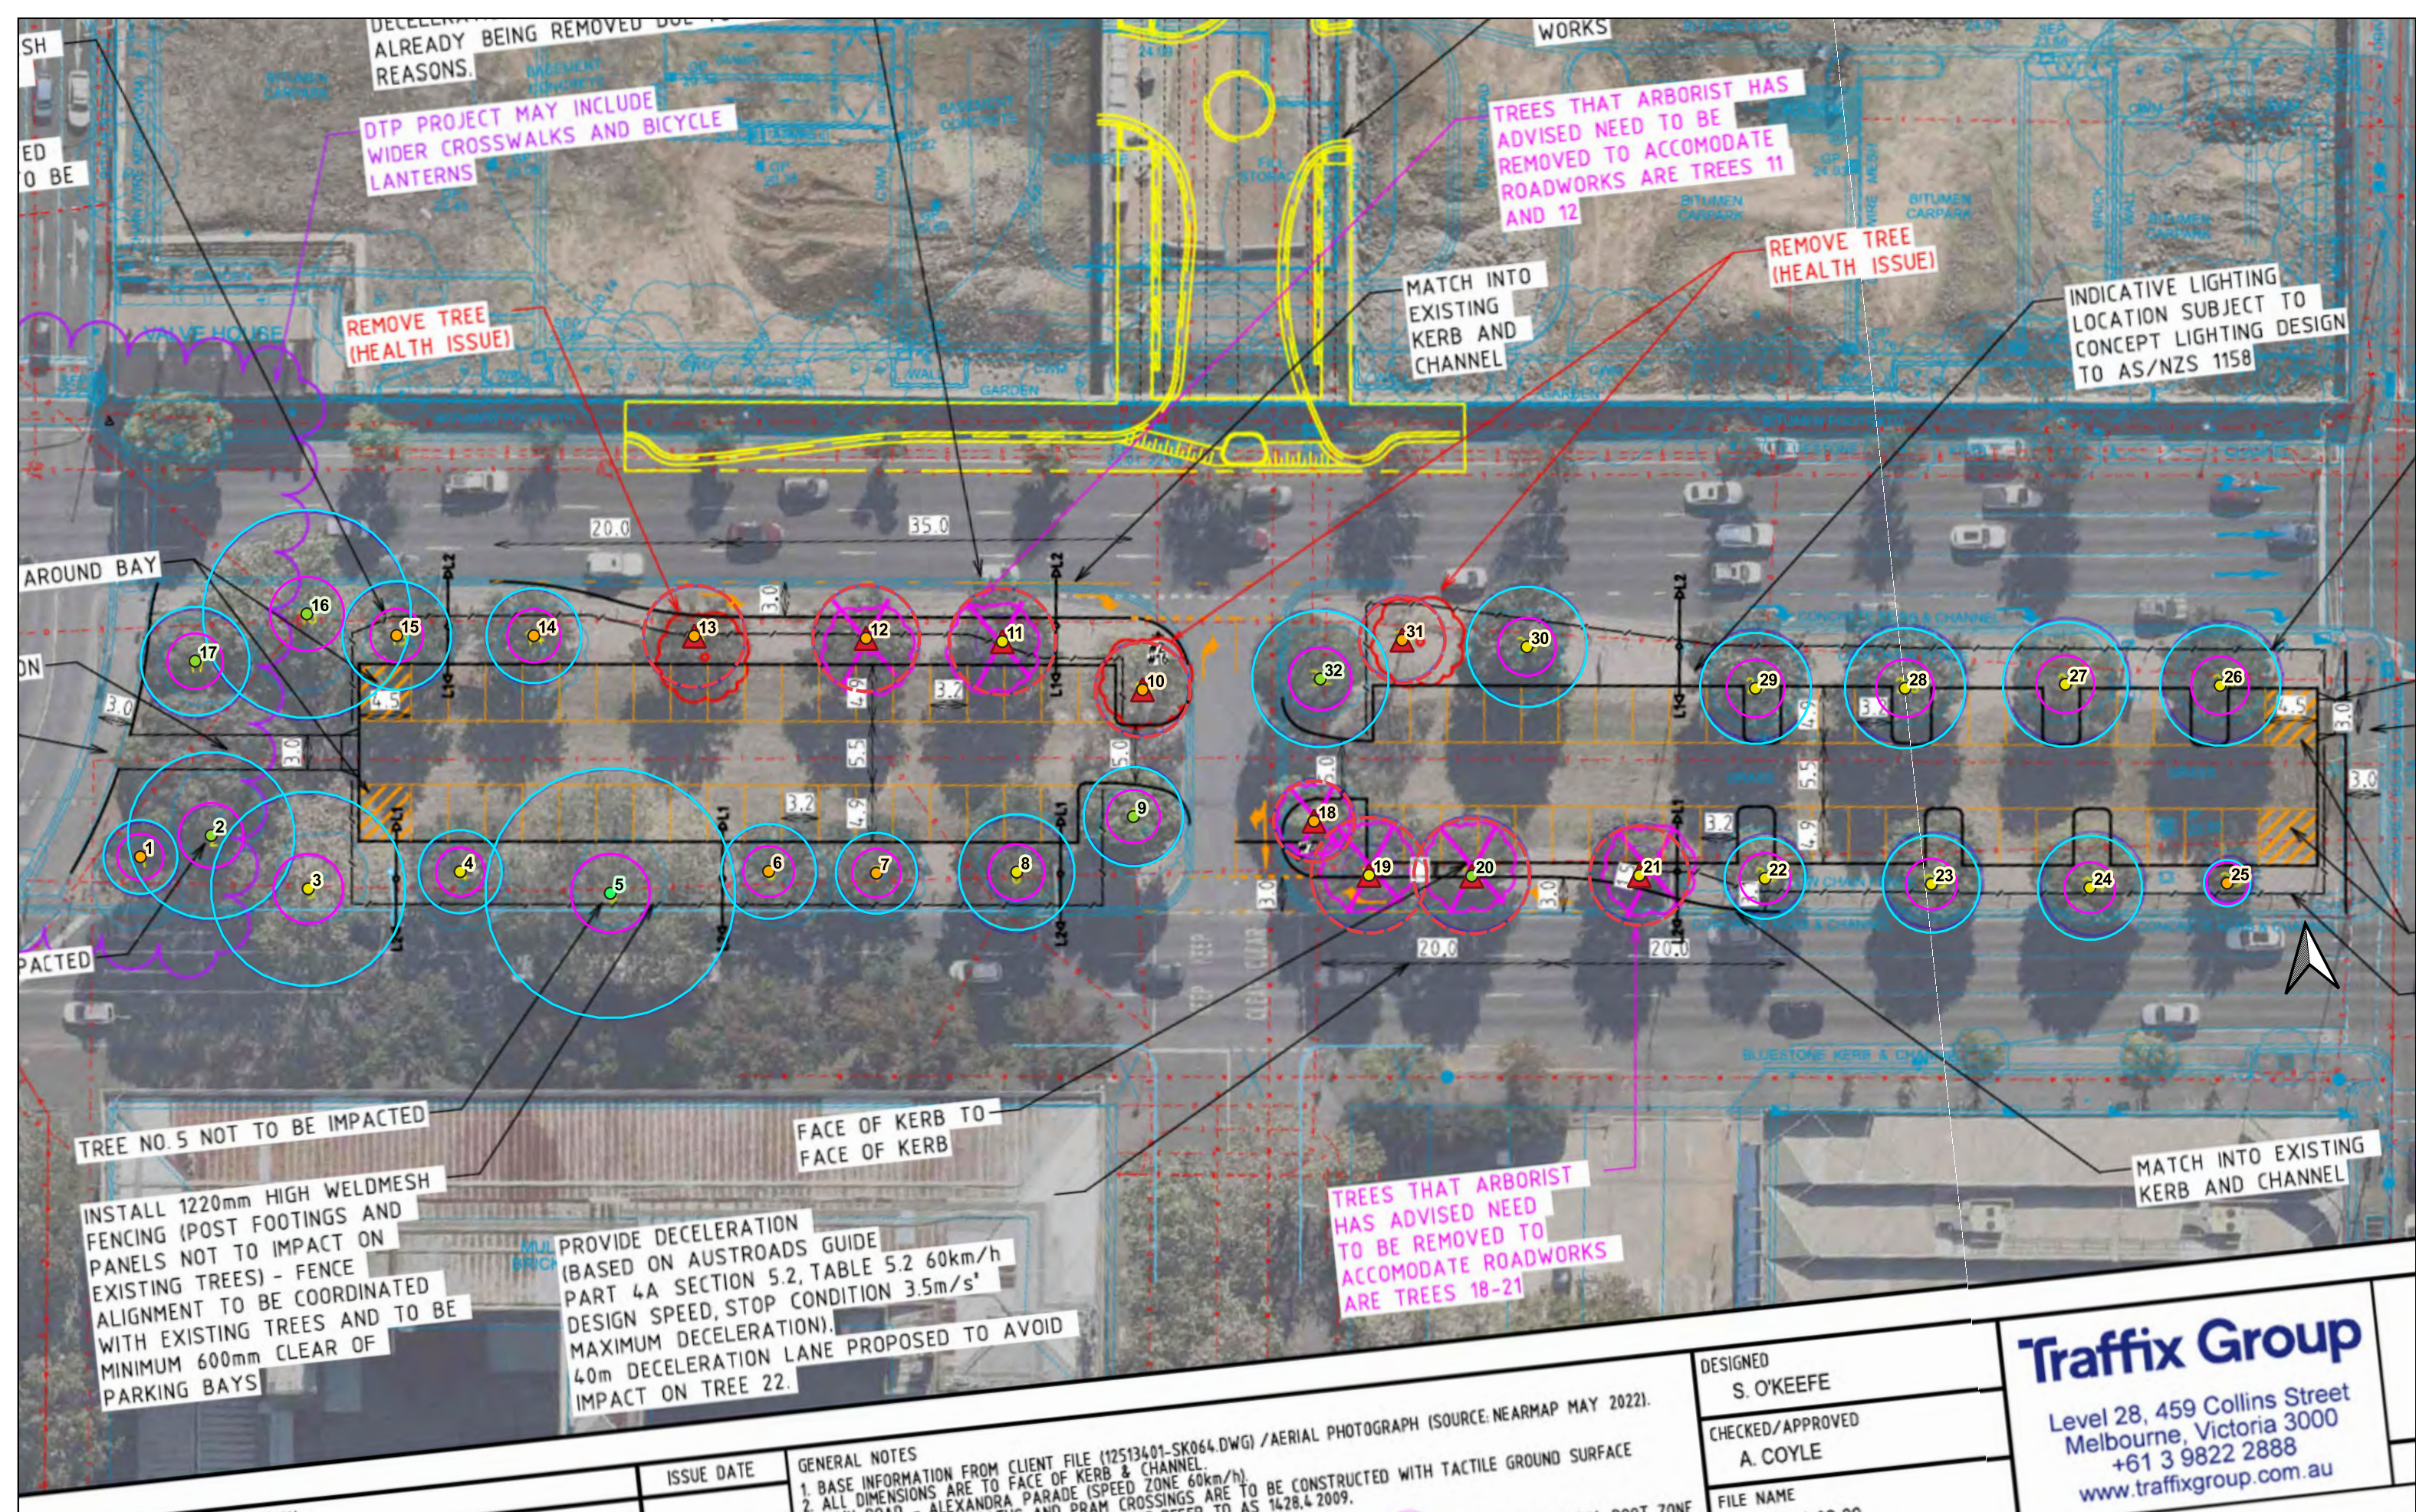
**APPENDIX 2A — TREE LOCATIONS AND PROTECTION ZONES**

- Open space allocations into the carparking spaces have been given to trees 22, 23, 24, 26, 27, 28, and 29. While these trees will experience encroachment of their SRZs, if the works are conducted according to the recommendations above, in our opinion they are likely to tolerate the proposed design.

- Trees 10, 13 and 31 are recommended for removal due to wounds, the presence of borers and generally poor structure.
- Trees 11 and 12 are impacted from two sides of their TPZ, to the north from the new sliplane and from the south from the carpark surface. These trees are unable to be retained under the proposed design.
- Trees 19, 20, and 21 are lost to the construction of a new sliplane allowing cars to enter the central access road between the two carparks. These trees are unable to be retained under the proposed design.

- No roots within the SRZ are to be damaged or cut. The carpark surface (grass grid section) must be installed at or above existing soil levels. Works within the SRZ of retained trees should be supervised by the project arborist.

- Maintenance of an exclusion zone over the open ground around the perimeter of the carpark will be critical to realizing the retention of the trees in question. This open ground represents the new ground space where trees will be able to regrow roots that may be lost to changes in conditions. Strict tree protection exclusion fencing should be installed before works commence and maintained for the duration of the works.
- No storage of machinery or materials should be allowed in this protected space.

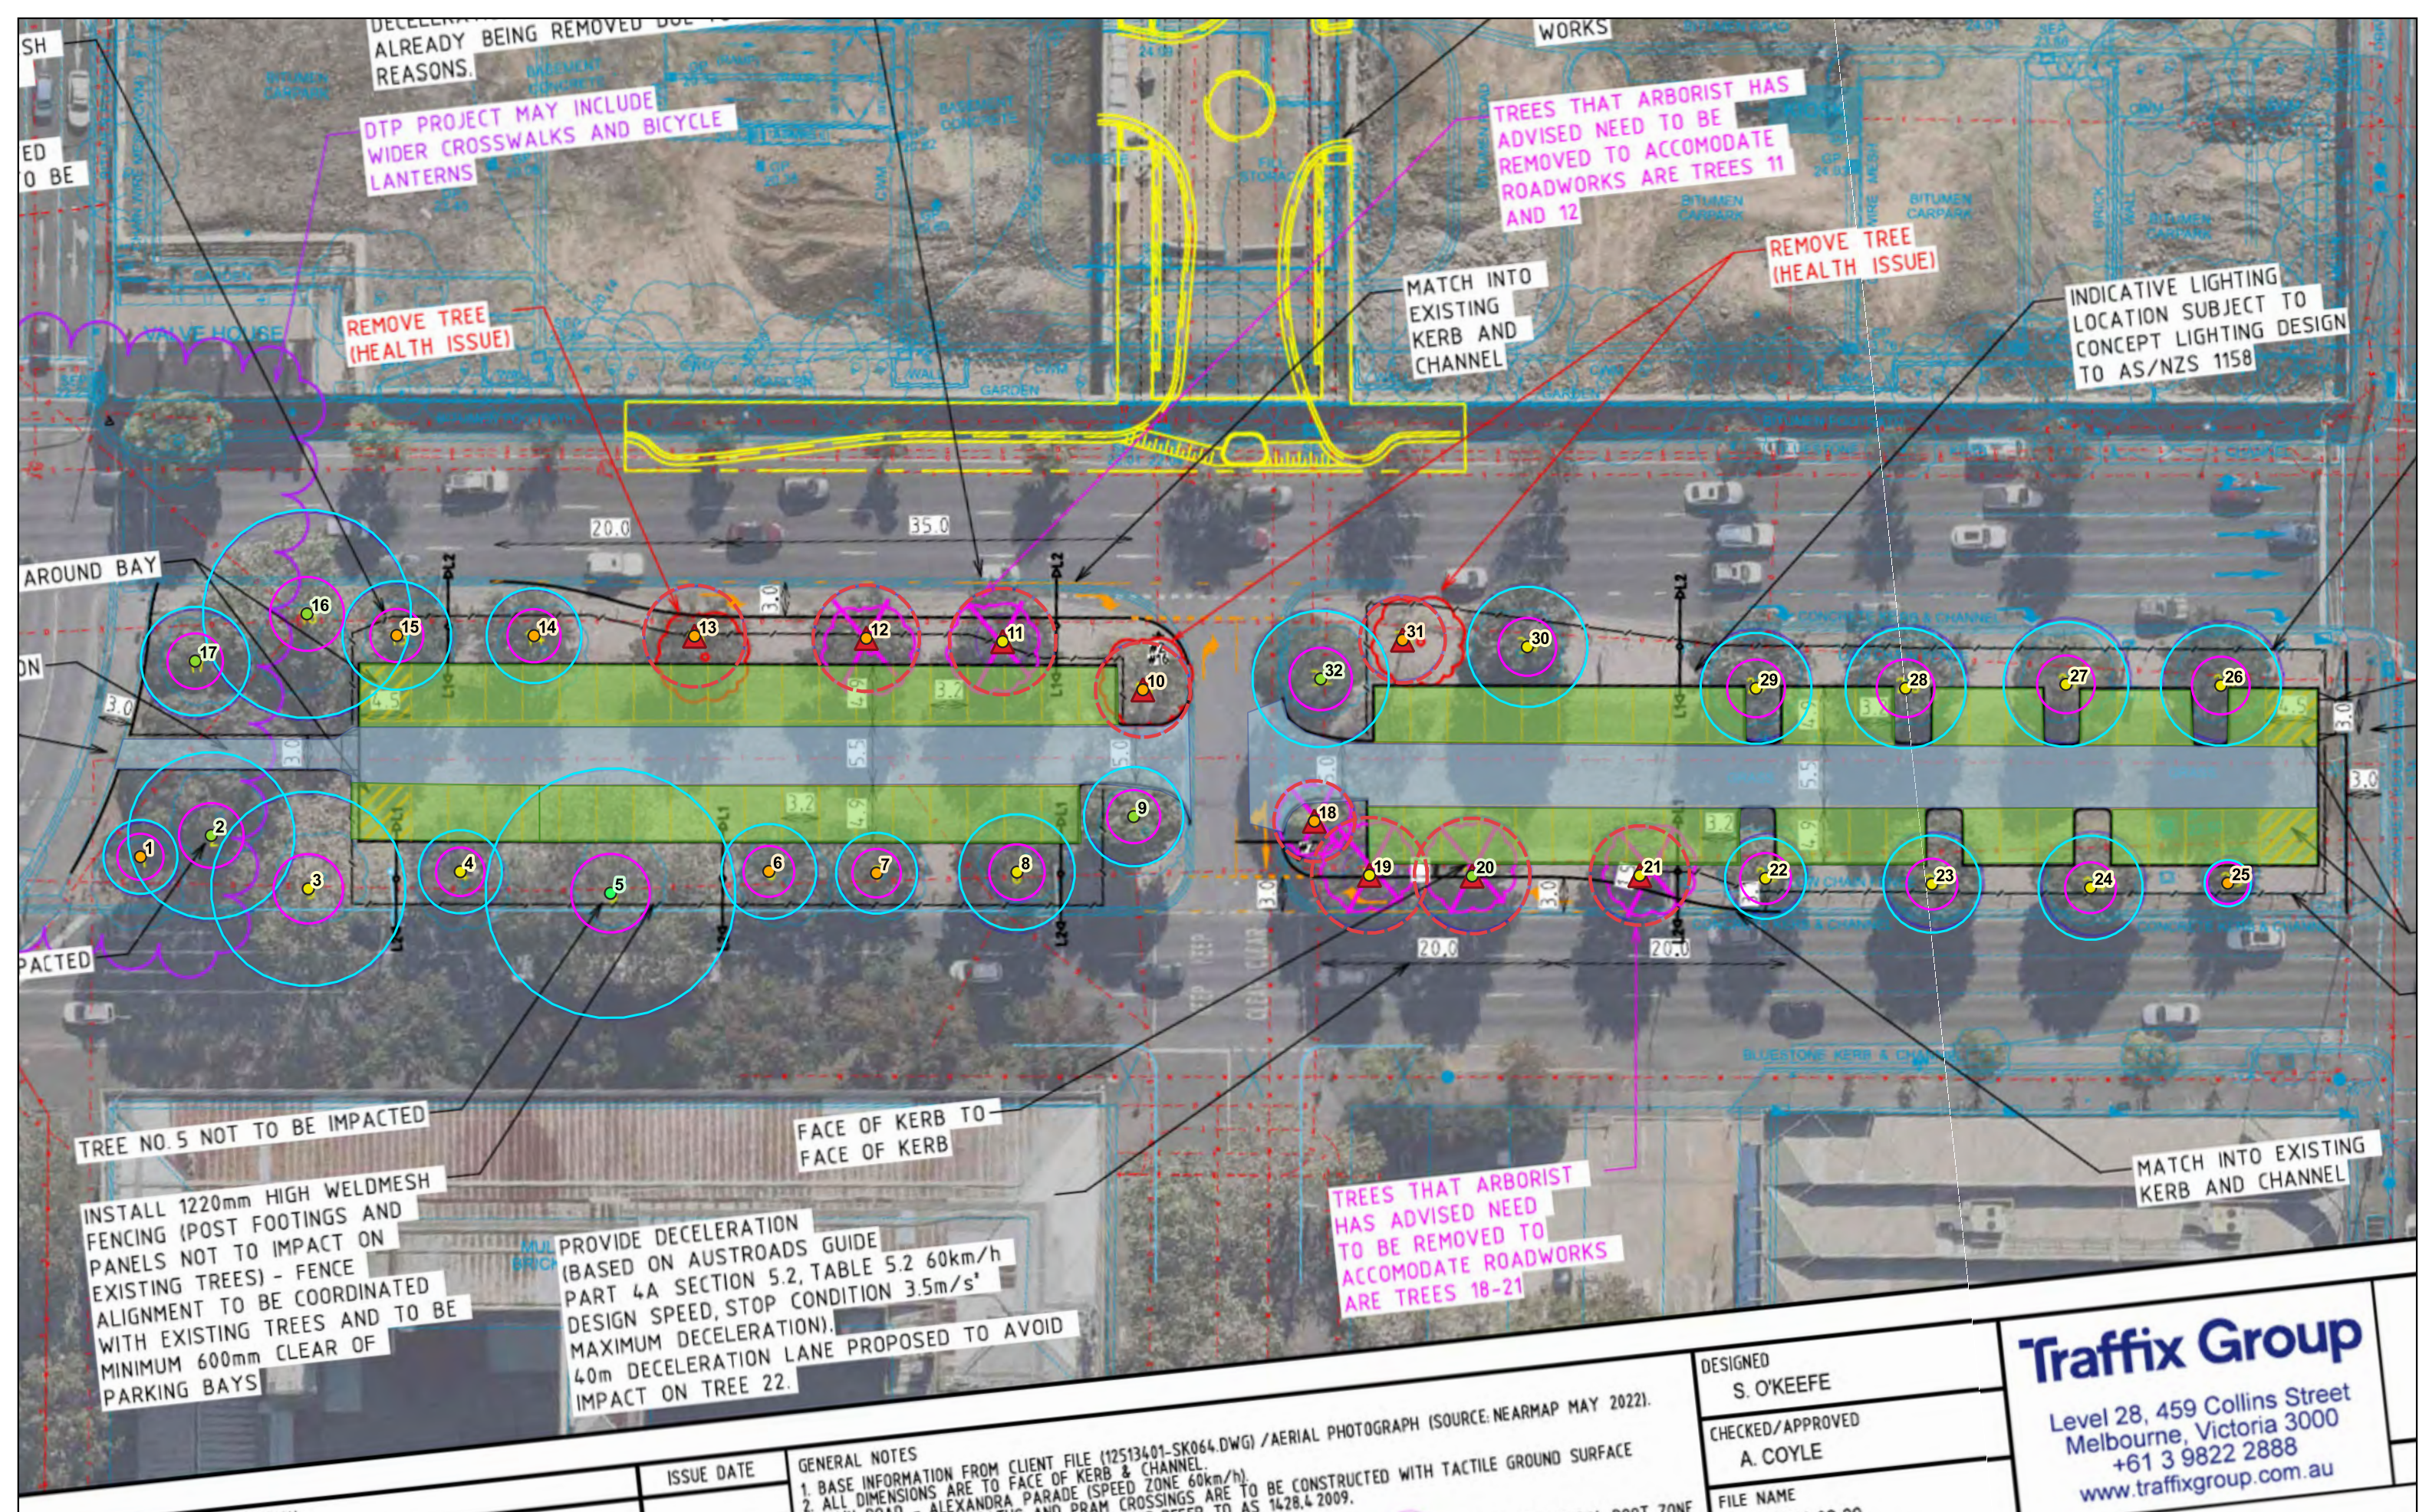
**APPENDIX 2B — TREE LOCATIONS AND CONSTRUCTION METHODS**

- Trees 10, 13 and 31 are recommended for removal due to wounds, the presence of borers and generally poor structure.
- Six trees are lost due to impacts from the proposed design. Trees 11, 12, 18, 19, 20, 21.

- Maintenance of an exclusion zone taking in the open ground around the perimeter of the carpark will be critical to realizing the retention of the trees in question. This open ground represents the new ground space where trees will be able to regrow roots that may be lost to changes in conditions. Strict tree protection exclusion fencing should be installed before works commence and maintained for the duration of the works.
