**INTERIM REPORT:**

Tree collapse and bank slump investigation on Yarra River adjacent to former Amcor site at Alphington

August 2019

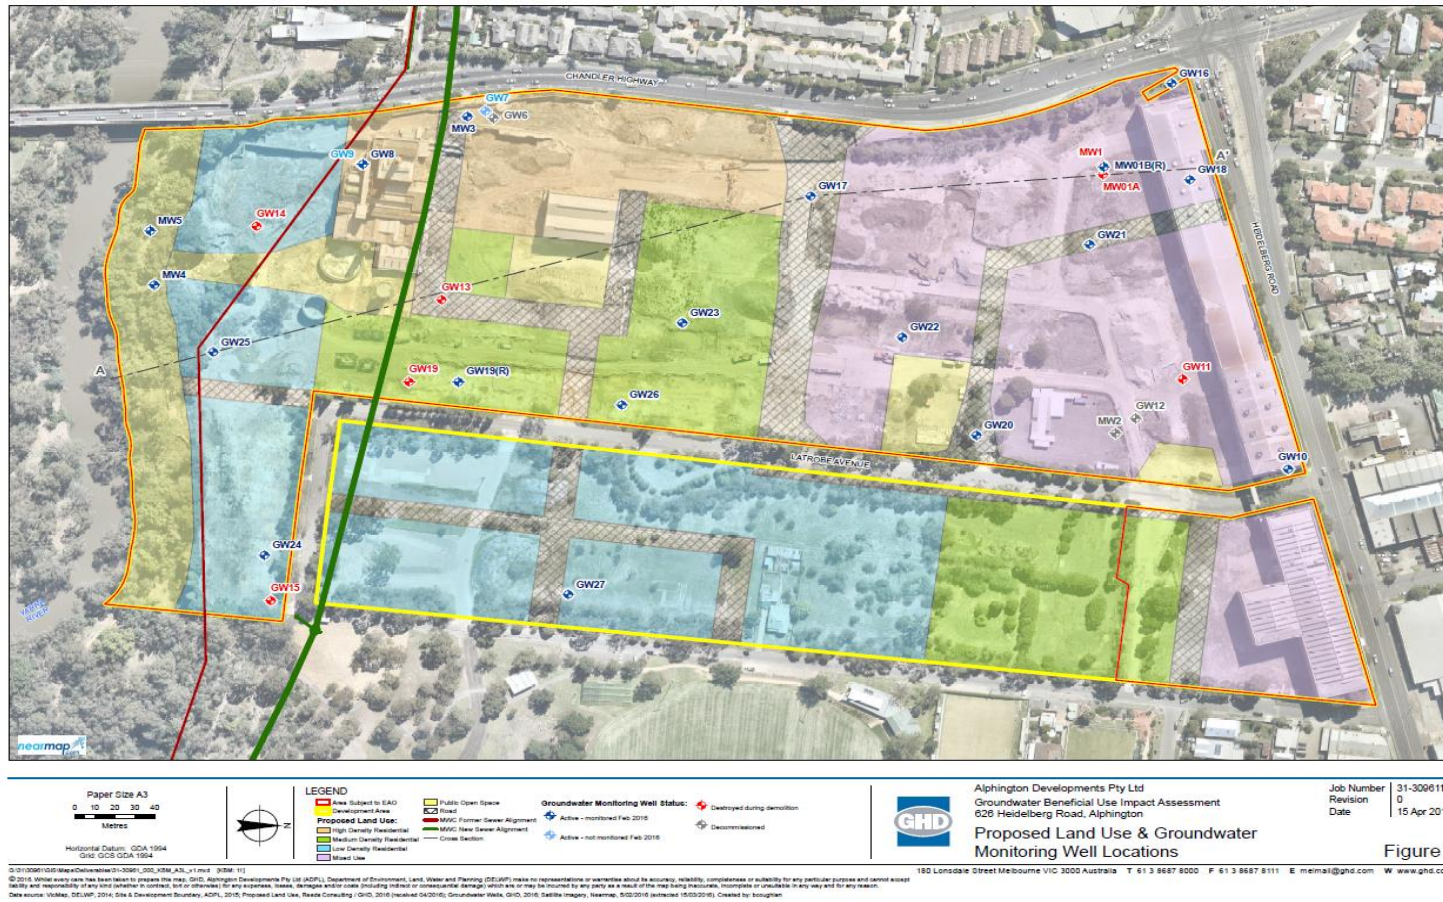
Figure 6-1 Bore locations (GHD 2016)<sup>2</sup>

Based on GHD's 2016 report, there were at least 31 groundwater monitoring wells at the site (Figure 6-1, Table 6-1). Over time, many of the wells were damaged and/or decommissioned. Groundwater level measurements from both

<sup>2</sup> Most of the bores have been destroyed or decommissioned as part of the site development.

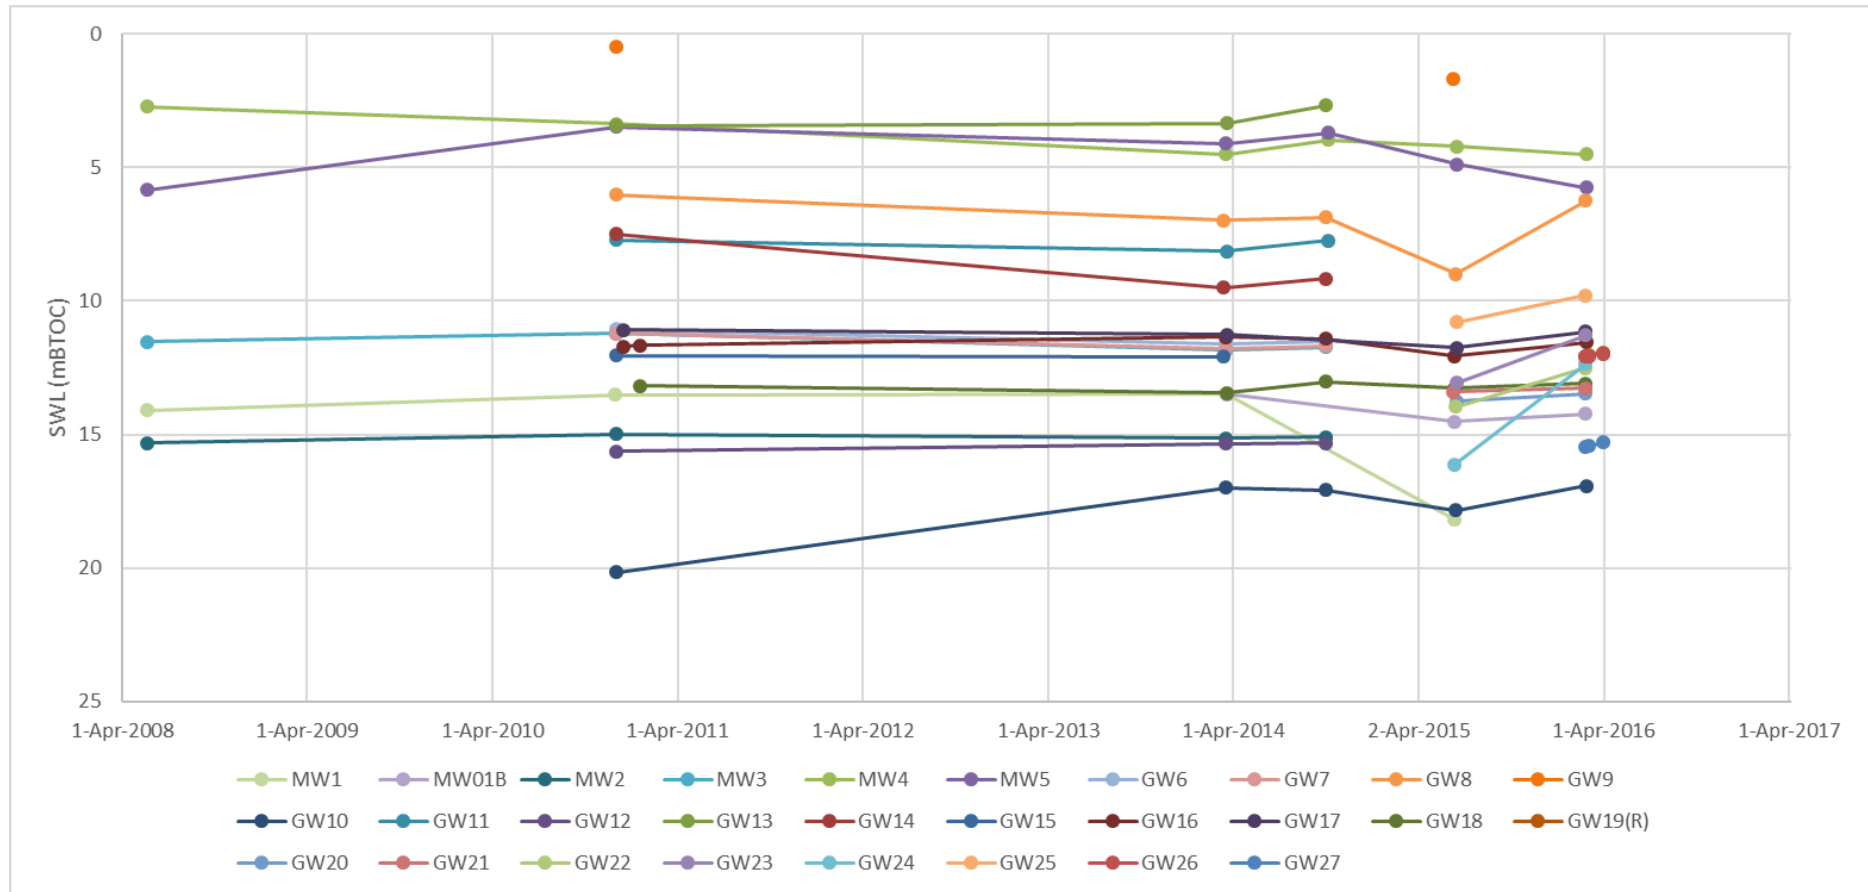
**Figure 6-3 Standing Water Level data extracted from GHD 2016**

The data collected during all the GMEs cannot be used to determine seasonal variations as the GMEs were irregular and the bores monitored varied considerably across all the GMEs (see Figure 6-3).

Standing water level (SWL) collected from these wells between 2008 and 2016 indicated that the SWL varied between 0.5 and 20 mBTC (as reported by GHD 2016). SWL were not reported as metres below ground level (mbgl) or metres Australia Height Datum (mAHD) (see Figure 6-3), thereby preventing the comparison between the river stages and the watertable.

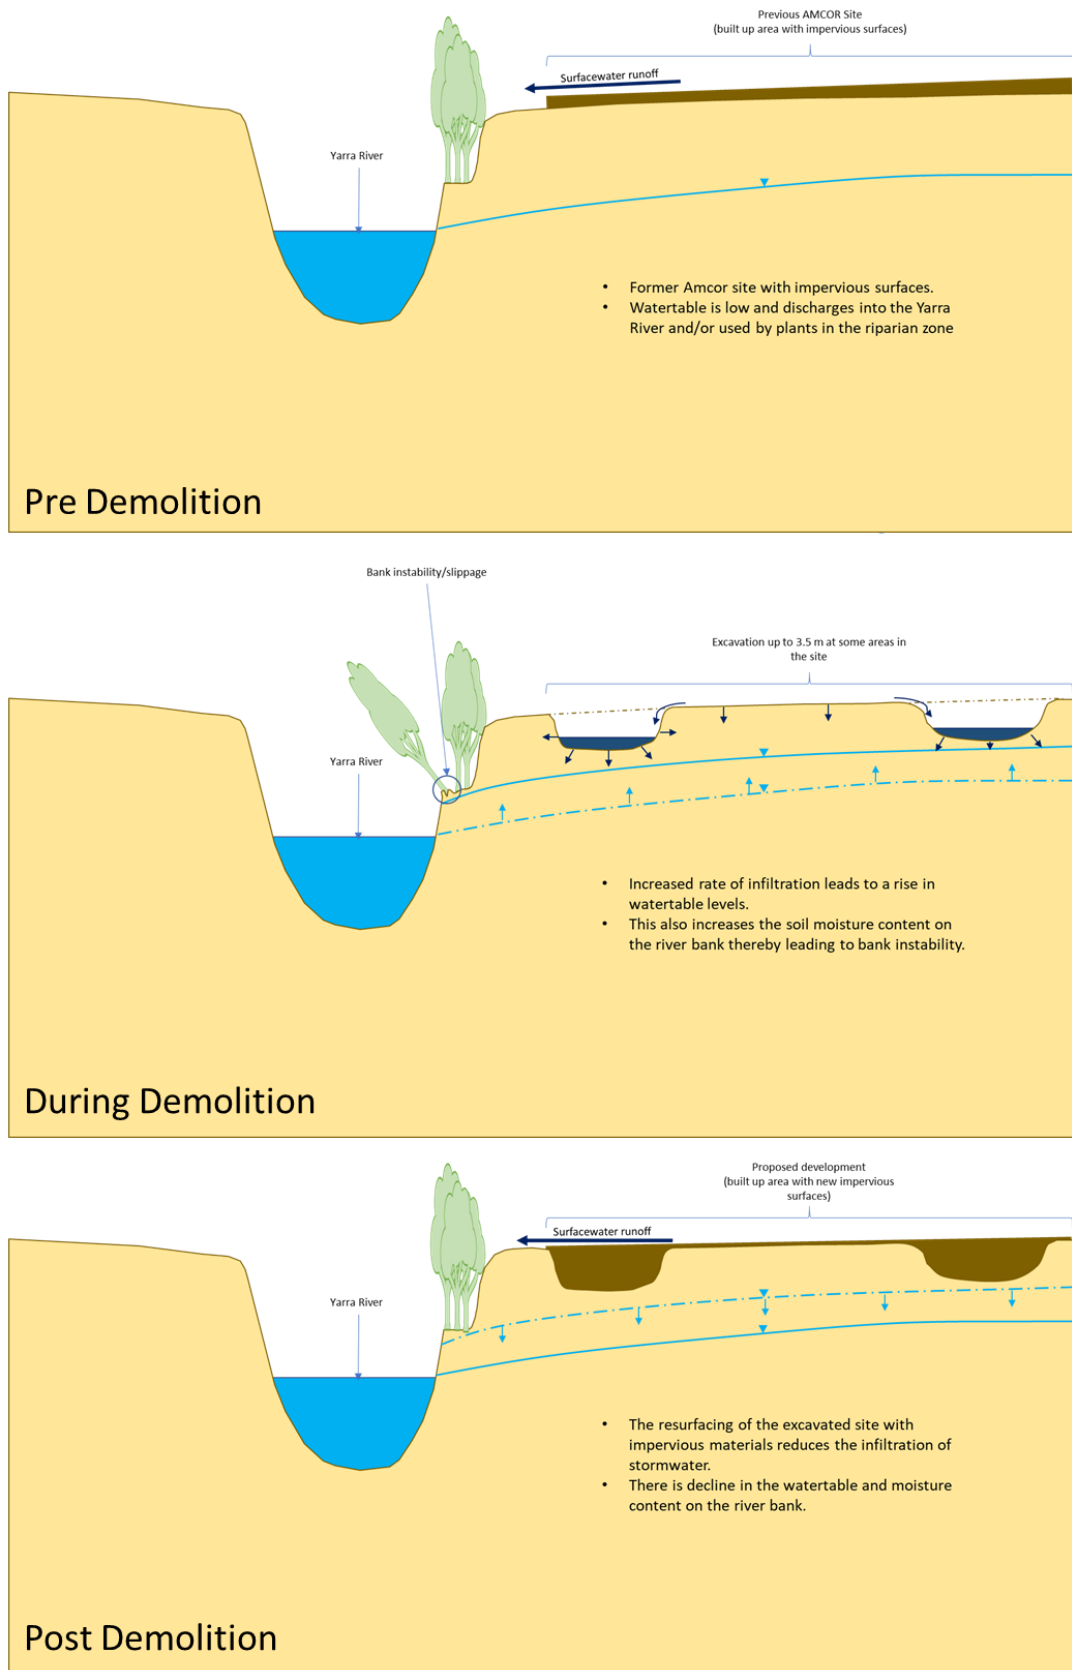
Figure 6-6 Conceptual site model

A simplistic conceptual site model provides an initial assessment of the likely role groundwater may have played in initiating the river bank collapse and how development activities have contributed to changing GW processes. The assessment area has been divided into 3 stages (Figure 6-6), pre-demolition and major earthworks (pre-2014), during development 2016 onwards, and a hypothetical post development:

The resurfacing of the Glenvill site with impermeable materials and the design of a proper stormwater collection system will lead to a reduction of percolating water into the underlying soil/HSUs. This will result in the continual lowering of the groundwater back to pre-demolition works, thereby lowering the accumulation of moisture within the bank. A proper stormwater collection system will also ensure that point recharge zones are eliminated.

The decline in the groundwater level and moisture content in the bank will reduce bank instability.

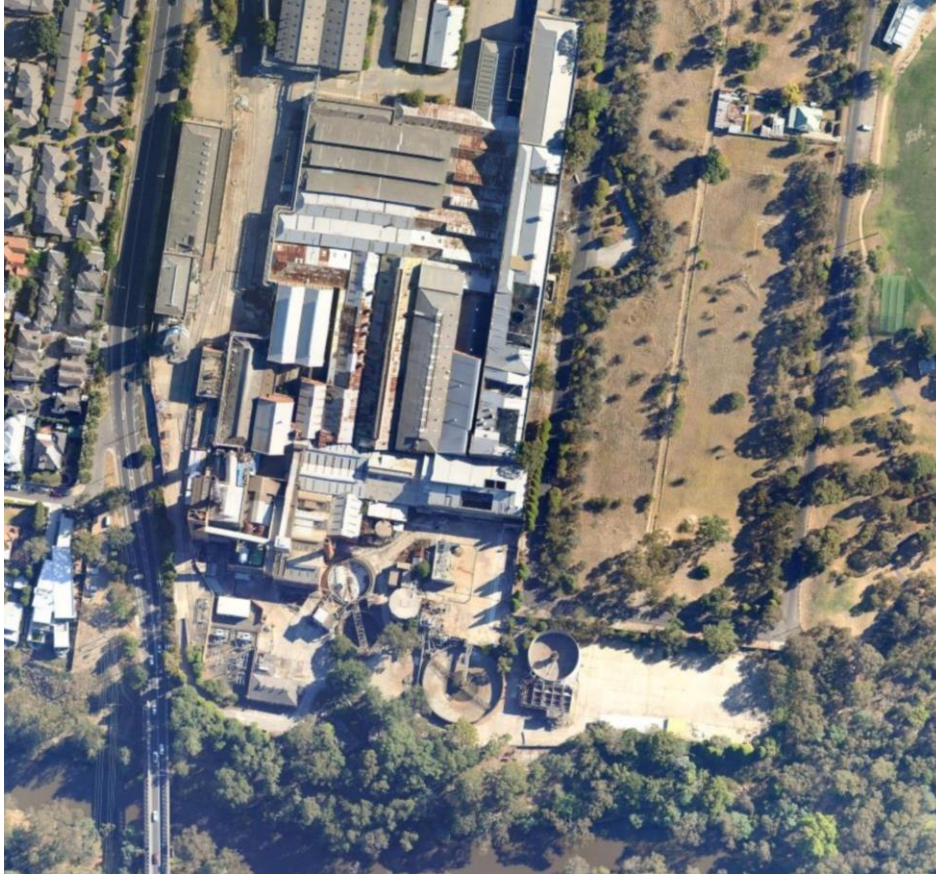
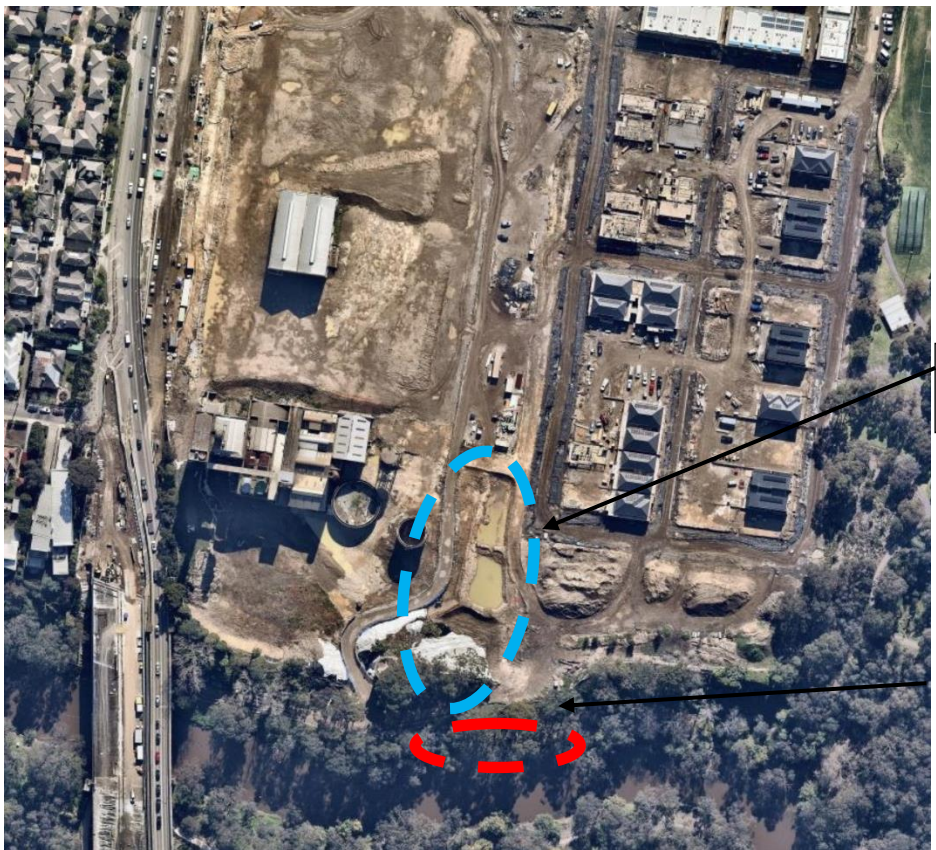
Figure 1 – Aerial photo of the site. March 2014 (top image), August 2018 (bottom image)

As shown in Figure 1, there has been a significant change in land use on the catchment over the past few years. Land use and hydrology are intrinsically related. Therefore, a change in land use is likely to lead to a change in hydrology. During the Amcor Paper Mill operations (i.e. pre 2015) the western portion of the site was predominately impervious (i.e. roof, hardstand areas etc) and it is assumed that the vast majority of stormwater runoff from these surfaces were collected and conveyed by a drainage system of gutters, pits and pipes that connected to the existing underground 1050mm pipe network through the site. The outfall from this 1050mm pipe was directly to the Yarra River. We estimate that very little of the rainfall that landed on the “western precinct” would have had the opportunity to infiltrate into the existing groundwater. On the “eastern precinct” the majority of the site was vegetated with grass and trees. A “bluestone open channel” conveyed any surface flows to the east of the Amcor site and into the Yarra River.

As shown in Figure 1, the stripping and demolition of the site removed all of the original underground drainage systems. Rainfall that falls on the site under these circumstances lands on exposed earth, where it runs along the surface to a swale drain or pools on the surface. During bulk earthworks, it is standard practice (and a permit requirement) to manage stormwater runoff to mitigate potential erosion and sediment laden water from entering the downstream receiving environment (i.e. the Yarra River). Therefore, as you would expect a “Construction Management Plan” was prepared by CSC Civil Constructions. One element of this plan included information on the protection measures to control stormwater runoff, which involved the use of swale drains or cut-off drains and a sediment pond (refer to Figure 2).

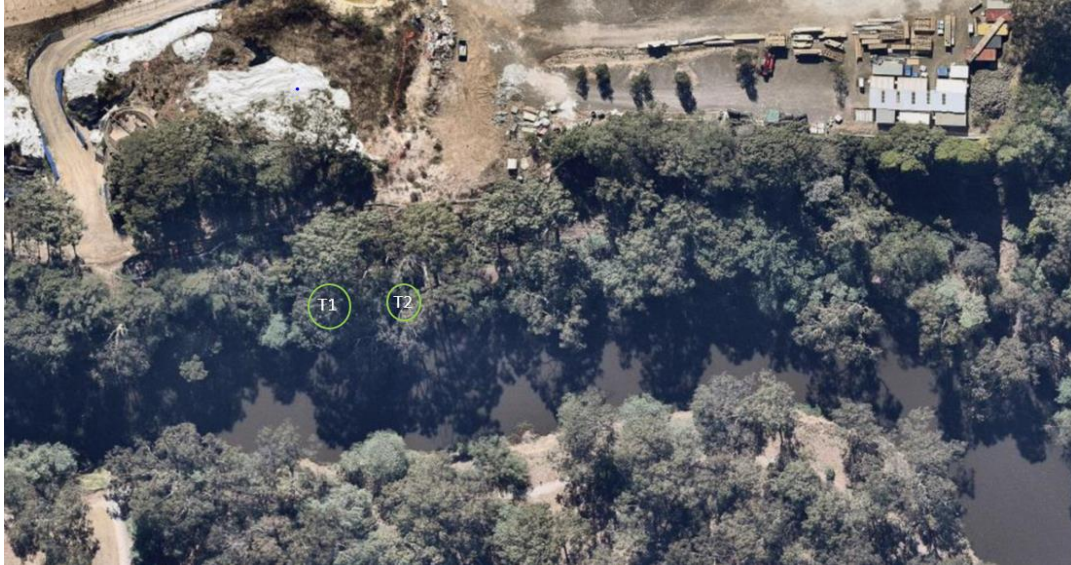
**Figure 10.** Location of trees assessed at bank slump zone

The site was walked from the site stormwater discharge point in an easterly (upstream) direction to the eastern boundary of the development. The bank slump and trees highlighted to be at risk were visited during the inspection. The location of the trees is shown in Figure 10

Three trees occur within and adjacent to the recent bank slump. One of these has fallen into the river and is not a major focus of this memo. The two trees identified as at risk of failure during previous visits by others are shown in Figure 11 and

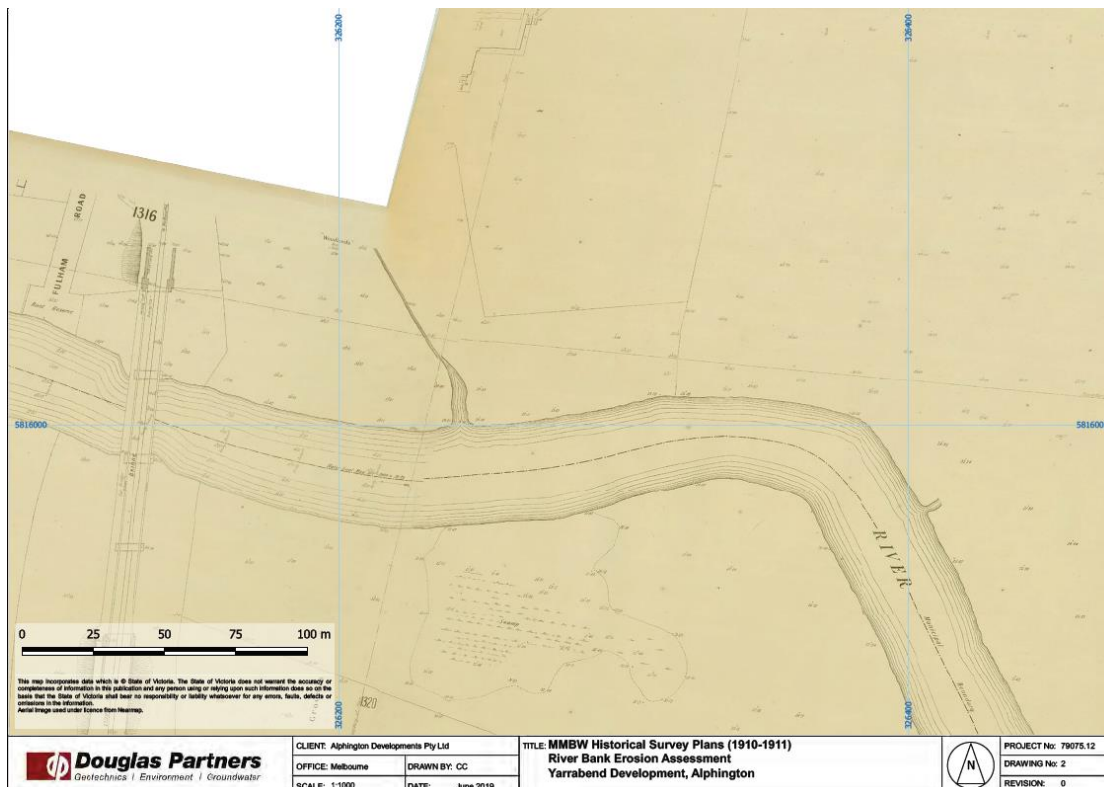
**Figure 20.** Old Creek location from historic survey

As set out above there is evidence of fill material on the lower terrace. Figure 20 illustrates provides an extract of a MMBW Historic Survey Plans (1910-1911) (refer Douglas Partners 2019) of a creek on entering the Yarra River through the now lower terrace of riverbank. Figure 21 sets out an indicative location of the creek in the current landscape. We are aware of a stormwater pipe located in the area of the old creek, however there is limited surface evidence of this creek in the current landscape, suggesting that the creek and its confluence with the Yarra River have been infilled.
